Final Report for

## KCTCS - LAUREL SOUTH CAMPUS FEASIBILITY STUDY SOMERSET COMMUNITY COLLEGE

KCTCS Somerset - 235 S Laurel Rd  
London, Kentucky 40744

1 September 2023

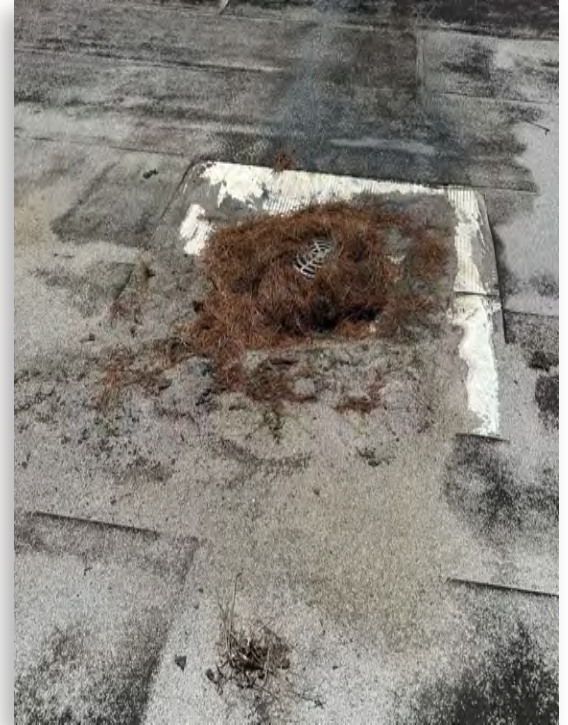
During WPA's site visit, the roof drains were covered with pine needles and deep piles of roof granules. (this can be seen in the photo to the right.) Additionally, there are blisters in the roof membrane visible beyond the drain.

The building exteriors need a number of improvements. The roof may be the most pressing of these. For a twenty-three year old roof, it is in pretty bad shape and there is evidence that water is getting under the membrane in many places – especially on the 1975 addition's roof. WPA recommends a full tear-off of the existing roof system to the deck and replacing it with IECC required insulation and a new SBS modified bitumen roof system. Alterations to the roof edges and new flashings around the perimeter will be required to respond to the deeper system thickness. Roof drains should be extended to the new roof level and equipped with overflow protection to prevent water from ponding on the roof when one or more of the four roof drains become blocked by debris from nearby trees. Most mechanical curbs will need to be altered as well (see MEP recommendations).

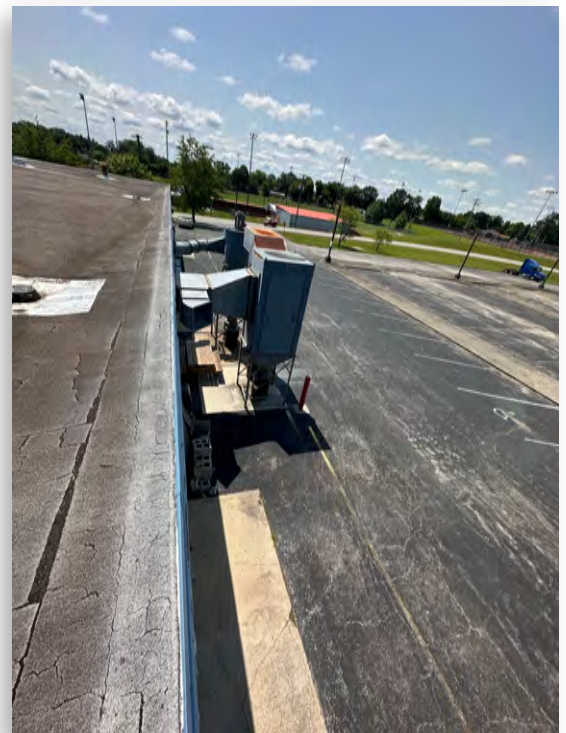
This photo of the roof edge at the rear of the original 1971 building shows the cracking of the membrane along the roof edges where granules have been displaced (darker areas) and the edge flashing detail. The mechanical unit seen on the ground below is the sawdust extraction system for the carpentry shop. This view also shows the condition of the existing parking lot.

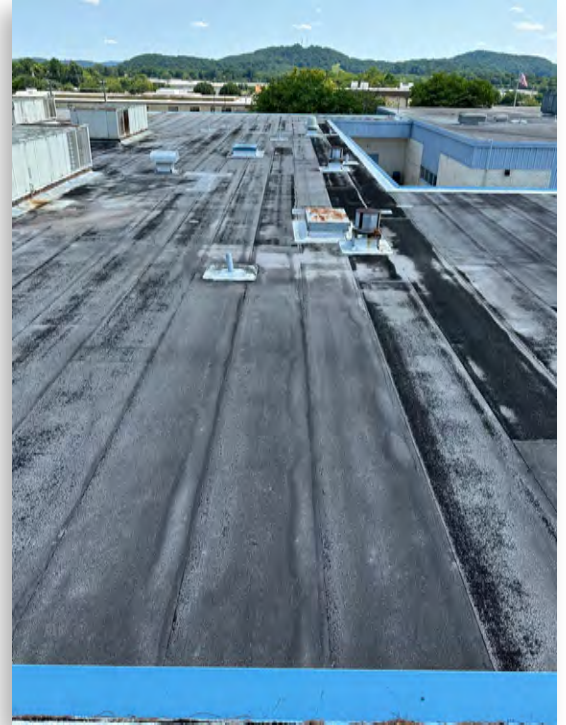
In this image, looking down on the low bay portion of the building, the long blisters in the roof are clearly visible. These occur when moisture gets under the membrane and becomes vapor as the roof heats up. It is safe to assume that the insulation under the membrane is wet and no longer providing much R value to the building. A new roof will require a full tear-off.

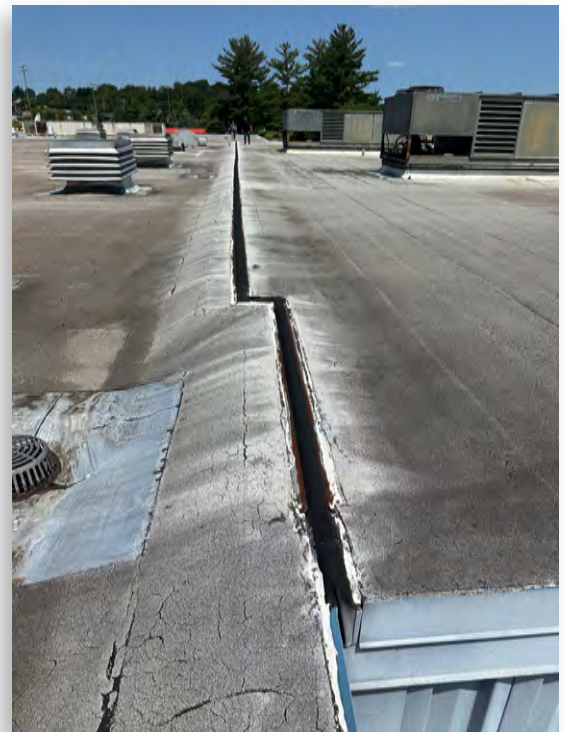
This photo shows the expansion joint on the roof of the original building. The joint runs above the wall of the corridor separating the offices and classroom portion of the building from the Construction and HVAC shop areas on the back side of the building. In the corridor below there is a long crack in the terrazzo floor running the length of the corridor. It appears some settling has occurred beneath this wall.

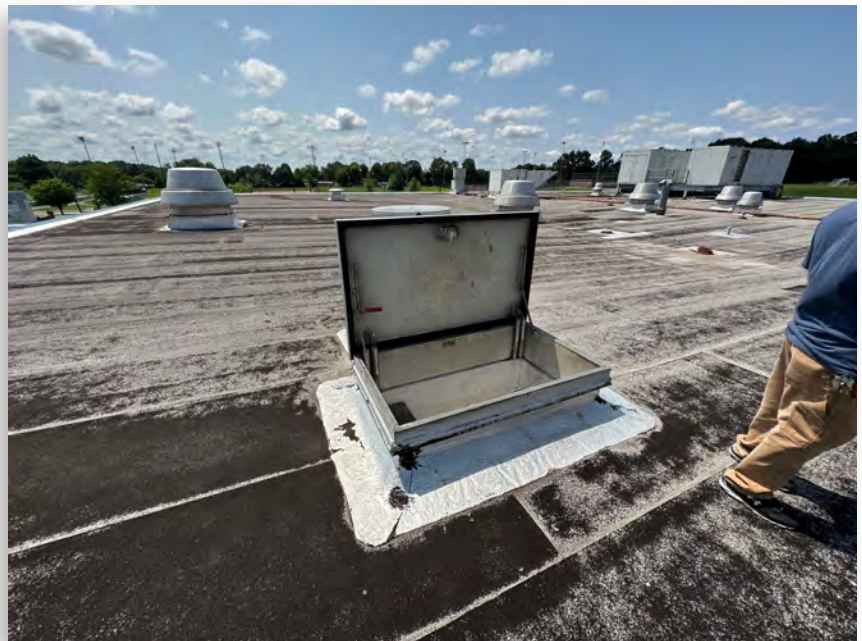
The loss of roof granules is very evident where there is frequent foot traffic on the roof. The area around the roof access hatch is nearly bare. A variety of low mechanical curbs likely to be affected by the increased thickness of the roof system in the background can be seen.

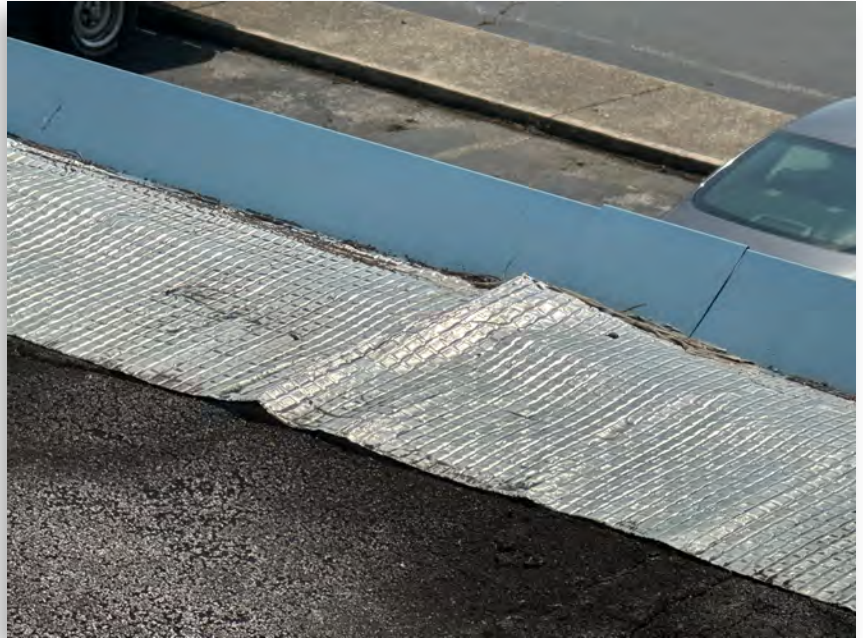
The foil-faced flashing at the roof perimeter is pulling up and damaged in many places. The gaps in the flashing where the material has stretched shown here, allow water to penetrate and enter the wall cavity

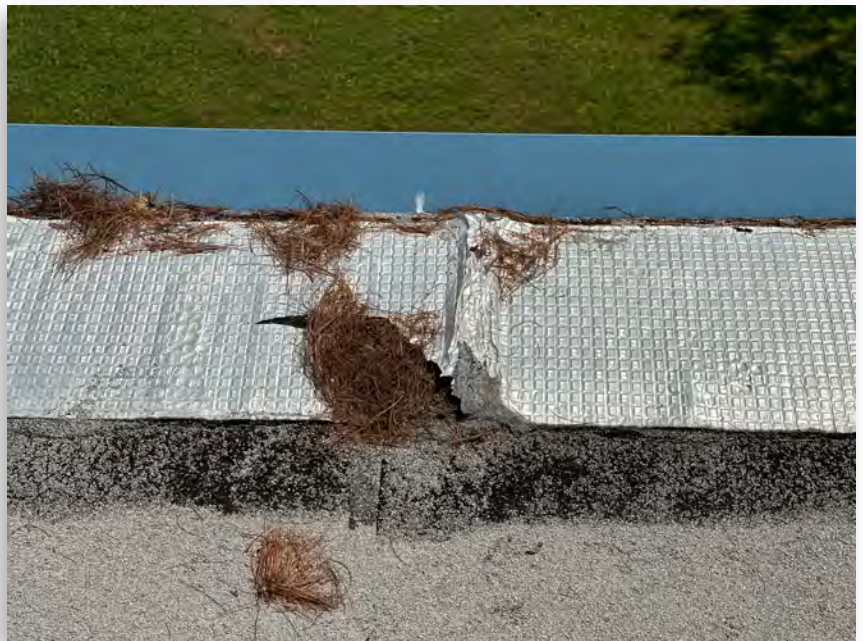
In other places, the flashing material is torn or missing. Here it appears to have snagged pine needles at the roof edge.

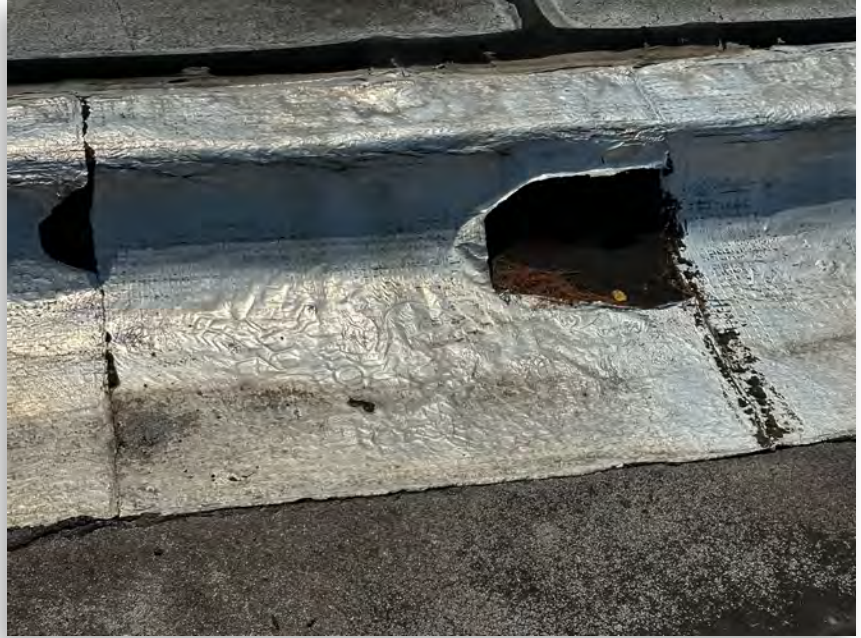
The damage to the foil-faced flashing is pervasive. WPA documented many conditions like the ones shown at roof edges, mechanical curbs and other features.

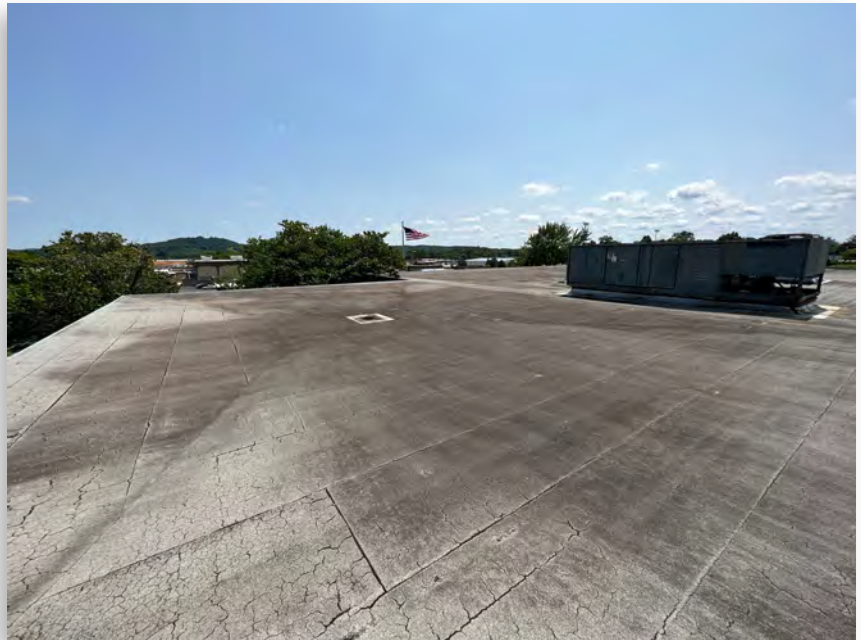
This overview of the original building's roof shows the state of the existing roof. Dark areas are places where the roof has lost granules. In the foreground extensive cracking of the membrane is visible. The low curbs on the mechanical unit on this portion of the roof is also visible. The roof drains on the original building do not seem to suffer from the presence of debris like the 1975 roof. The original building also has significantly more roof drains on its smaller area.

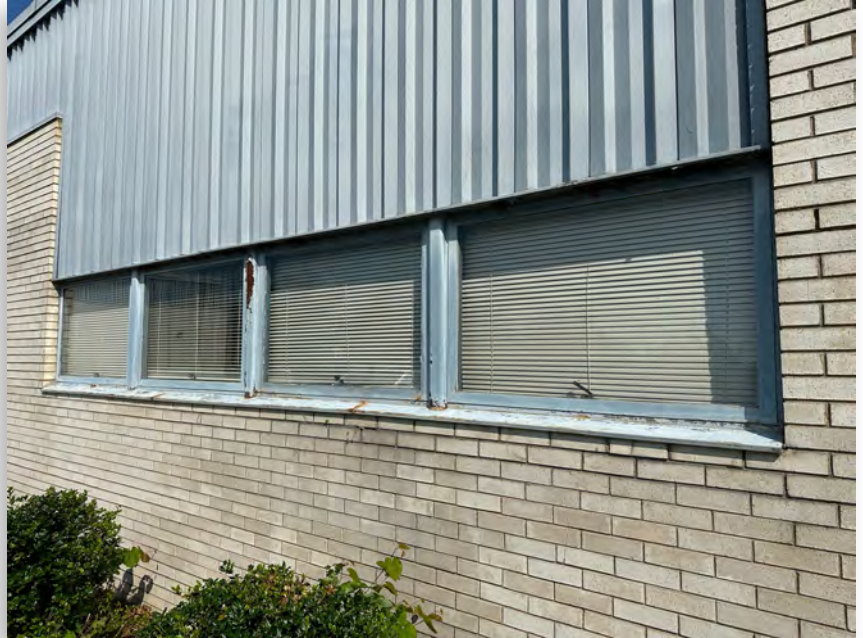
This is a typical steel window showing signs of rust in multiple places. These windows are uninsulated and not thermally broken allowing for thermal bridging that can cause condensation in the winter and summer. WPA recommends these windows be replaced with energy efficient ones. Note the discoloration in the bricks below the window and in a horizontal band at the left side near the window head. These are the signs that water is accumulating in the wall cavity.

The existing, steel, uninsulated windows should be removed, the openings properly flashed, and new, insulated and thermally broken frames with insulated, low-e glazing units installed. Exterior doors at main entries to the building should also be replaced with more inviting aluminum storefront frames and entry doors. The storefront systems should also be thermally broken and insulated and include insulated glazing in the sidelites and doors. Doors that are not part of a main entry (at shop areas, for example) should be replaced with new hollow-metal frames and doors that are insulated, thermally broken, hot-dipped galvanized and weather-tight. Any damaged lintels should be repaired or replaced, all rust removed from existing lintels and repainted. New lintels should be hot-dipped galvanized and painted. All of the large, over-head coiling garage doors should be replaced with insulated ones with new motors and rails. Jambs and heads should be repaired and prepped to allow the new doors to seal properly when installed.

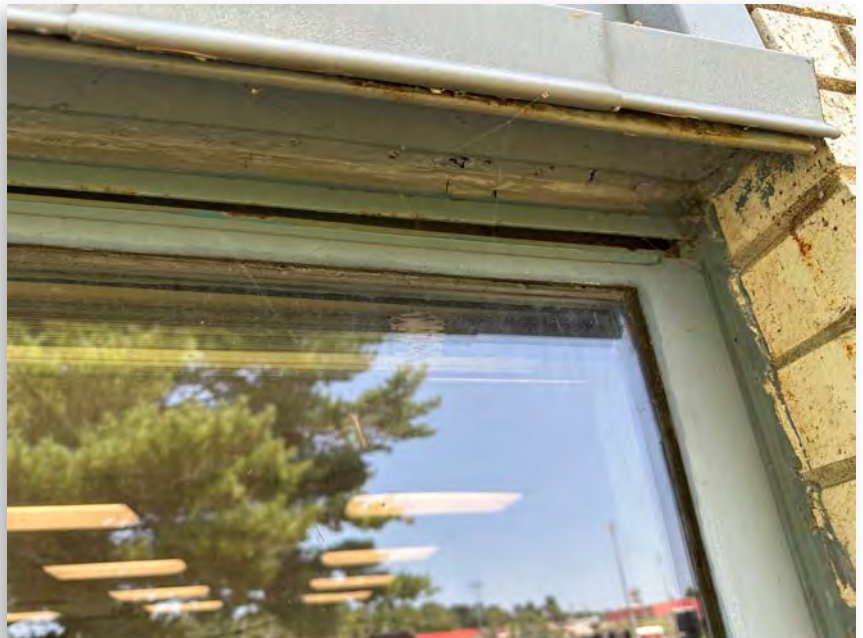
This steel window has a damaged sash that does not seal properly. There are signs of rust in the gap at the top.

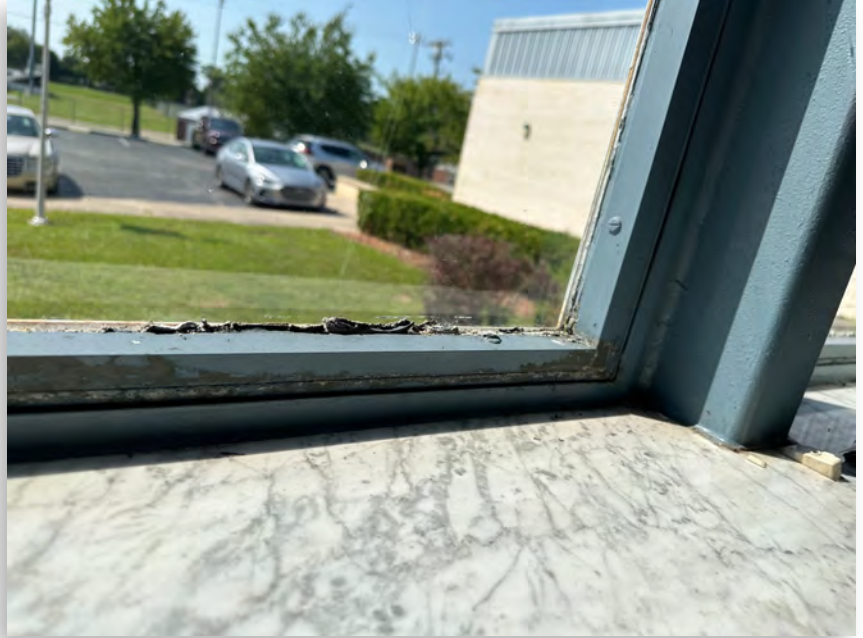
This image shows the deterioration of the glazing sealant in this window. The bottom of the sash is also showing significant wear.

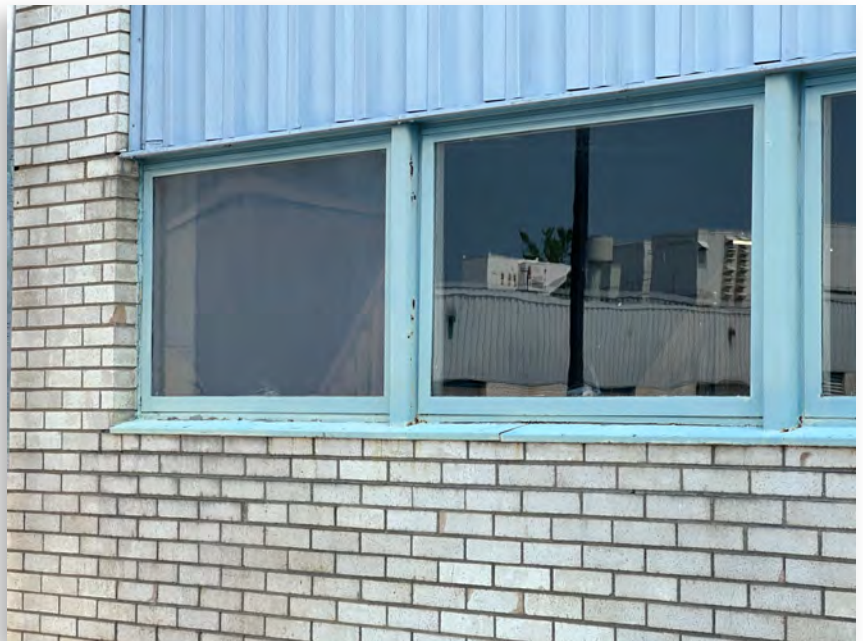
This image shows another window with rust in various places. This window also has a damaged sill that is allowing moisture into the wall cavity below the window. Note the gap between sill lengths under the middle sash.

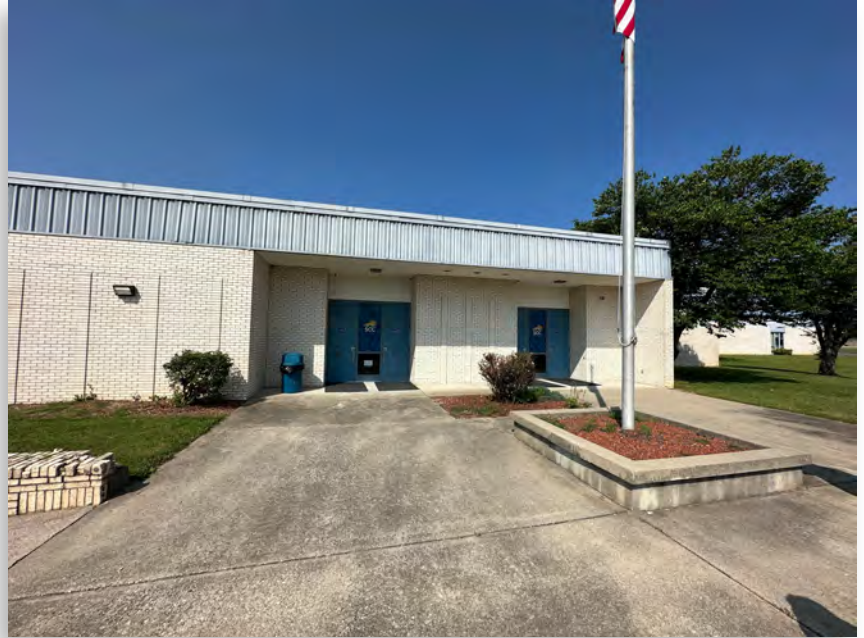
This is the main entry to the Laurel South Campus. The two pairs of doors – each separated by a sidelite – are flush hollow-metal doors. In addition to being in bad shape, these doors do not provide an appropriate first impression to the campus.

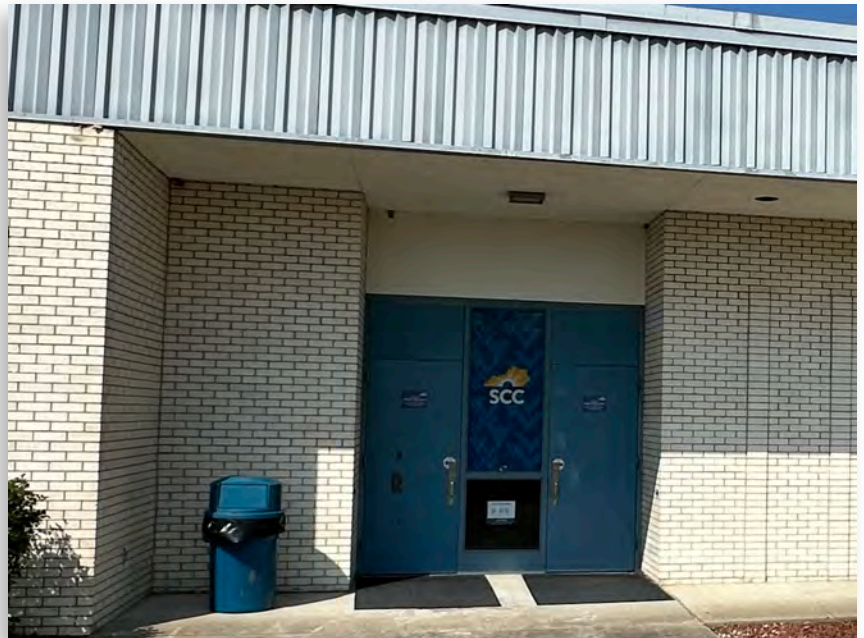
This enlarged section of the previous image shows the damage to the doors and the infilled transoms above each door. Most outward-swinging exterior doors are also showing rust on the hinges as well as the bottoms of many frames. The configuration shown here is typical at most entries.

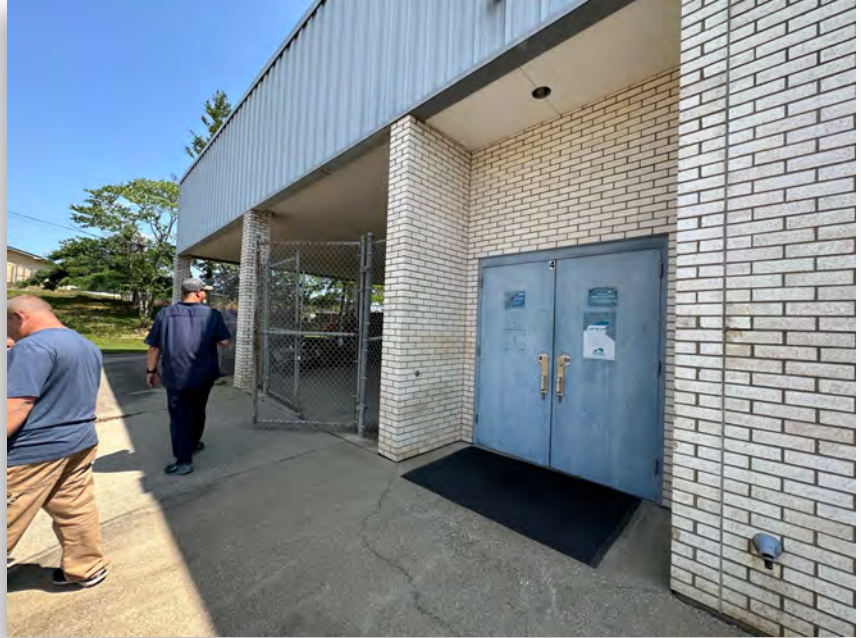
All exterior hollow-metal door frames have a 4" head. Many doors like these have been fitted for multiple hardware sets over the years and were not typically repainted to cover the locations of old hardware. The doors here at the end of the main corridor in the 1975 addition are in particularly good shape.

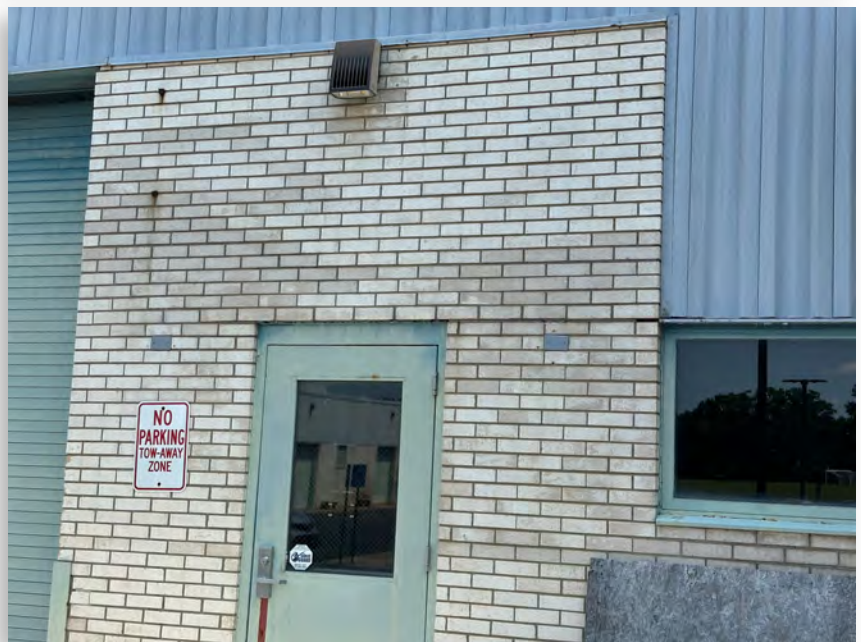
This door into the carpentry shop area shows bare metal where an old lockset was removed. There is rust on the panel at the lite kit and the lintel above the door is rusted. The discolored bricks above the lintel hint that water in the wall cavity has collected there, causing the lintel to rust and swell which is also causing the mortar joint to pop out. Water stains on the frame head also indicate that water has worked its way out below the lintel.

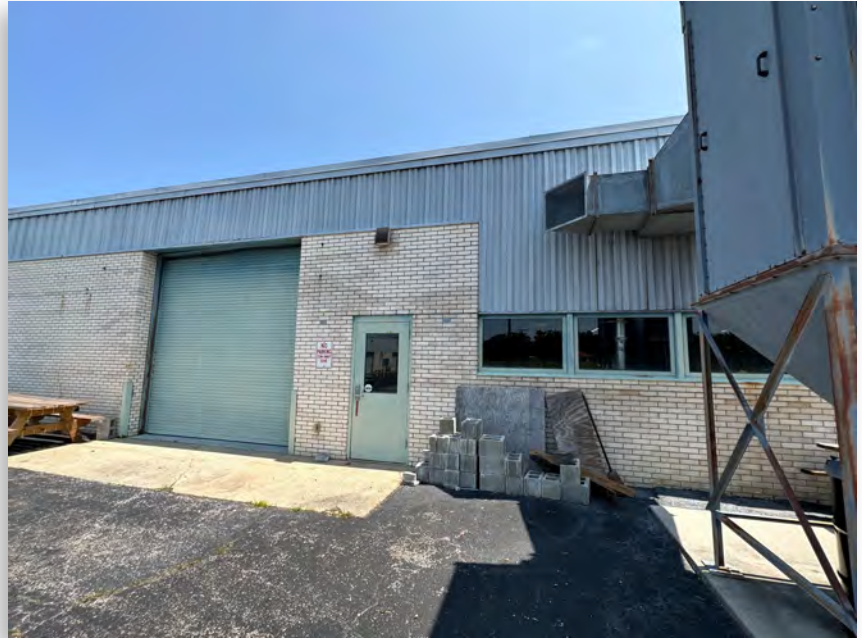
The over-head coiling garage doors typically extend to the top of the brick as shown here on the original 1971 building. The jamb on the left side of the door is showing rust which begins about 32" below the top of the brick. A line of discolored bricks to the left of the door suggests there is a relief angle there collecting water.

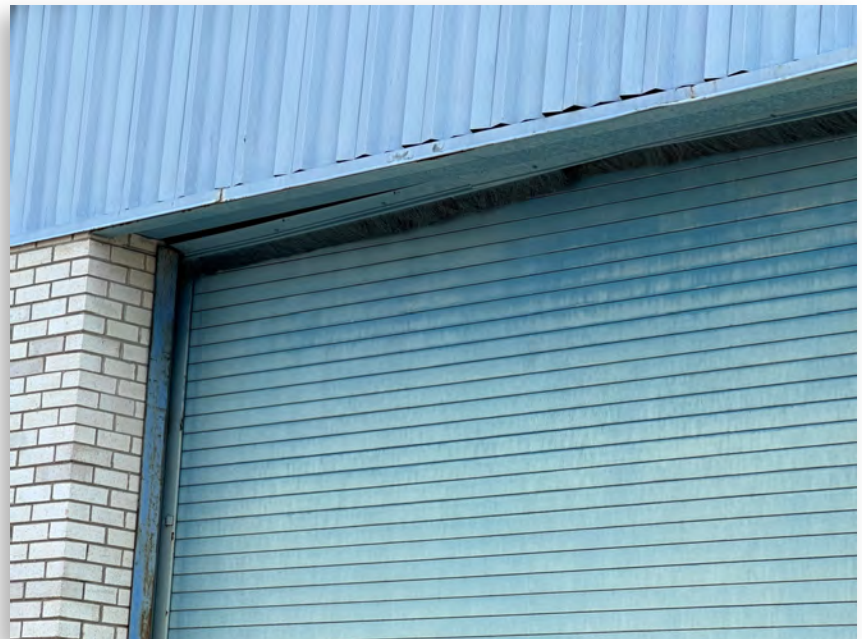
This detail of the same door shows a damaged sweep at the top of the opening as well as a portion of the metal panels that is not closed off properly at the bottom edge. The condition repeats in many places around the perimeter of the building. This may be due to differential expansion and contraction between the masonry and the panels.

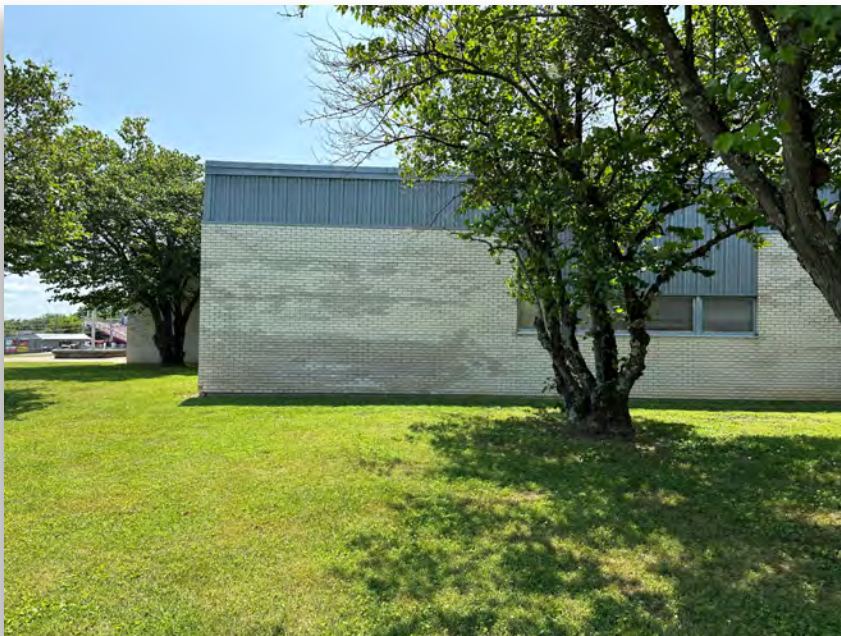
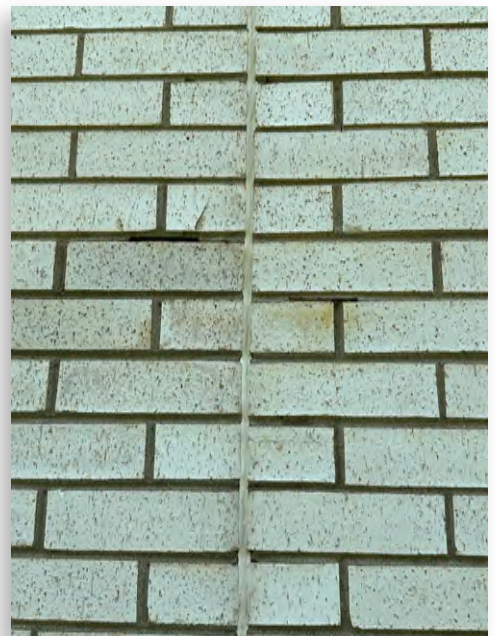
During our site visit, WPa documented a lot of damaged mortar joints that regularly occurred every 32" vertically around the building. When inspected, the mortar joints were loose in between the bricks and falling out of the wall in many places. In other places, the rusted steel edges or angles were seen poking through the mortar. The presence of relief angles is common in buildings constructed in this time period. However, there is a growing opinion that they were designed and located incorrectly and often with greater frequency than was actually needed to relieve the loads in the masonry. In an article by Brian E Trimble in Structural Magazine (May 2009), he states that guidelines for relief angles require them at 30'-0" vertically in steel structures and not at all in CMU structures. That is considerably greater spacing than seen at Laurel South.

The fact that the steel angles are visible is also cause for concern as the proper detail for the angle provides a mortar joint under the angle leg, flashing, a weep above the angle and finished off with backer rod and sealant at the wall face. (BIA Technical Note 18A "Accommodating Expansion of Brickwork" – See Appendix C). With the presence of rusting and discoloration in the bricks, it is obvious that the flashing and weeping of the angles was not performed or has been hindered by the very thin air space in the wall cavity. It is possible that the angles were actually intended to act more like a masonry anchor in the wall.

The brick and mortar issues are tricky and there is no easy way to replace the rusting relief angles without removing the exterior brick and re-building it. The relief angles could be replaced with hot-dipped galvanized angles at that time and the condition of the wall cavity insulation could be assessed, remediated and resolved before new brick is re-installed. It is possible that a new roof, new flashings and new metal panel skins at the top of the wall would halt the ingress of moisture into the wall cavities and prevent further rusting and expansion. Under those circumstances simply repairing the damaged mortar and brick could suffice but there is no guarantee that the rusting wouldn't continue to expand from some other cause. Regardless it is safe to assume that the wall insulation in the discolored areas is of little value at this time for energy efficiency.

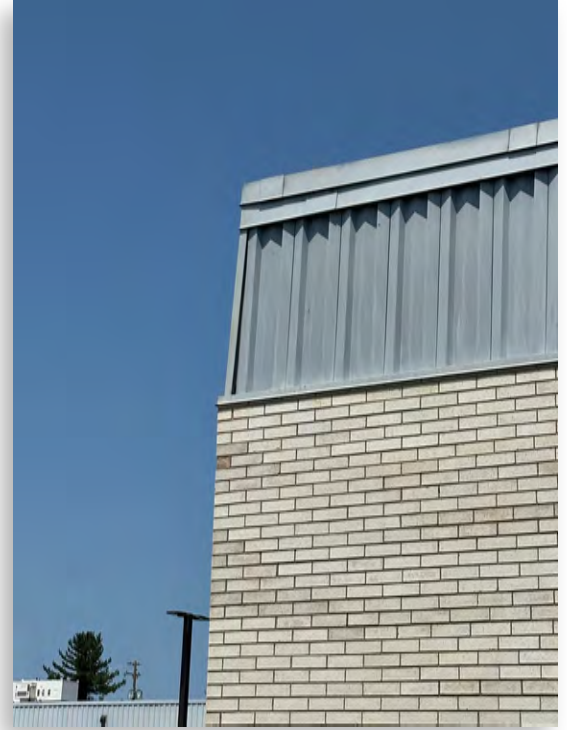
The deformation of the upper, metal-panel-covered portions of the building is shown here at the South corner of the original building. This is the most pronounced instance and may be partially due to the lack of masonry expansion joints on this portion of the building. There are bricks in many places that have spalled faces like the one five courses down from the top of the brick area.

WPA recommends replacing the metal panels at the tops of the walls to make sure they are flashed properly and weather-tight. In areas where there appears to be horizontal movement in the top portions of the wall, a structural engineer should evaluate the cause and whether it is a item for continued concern or the remnant of building settling that has stopped.

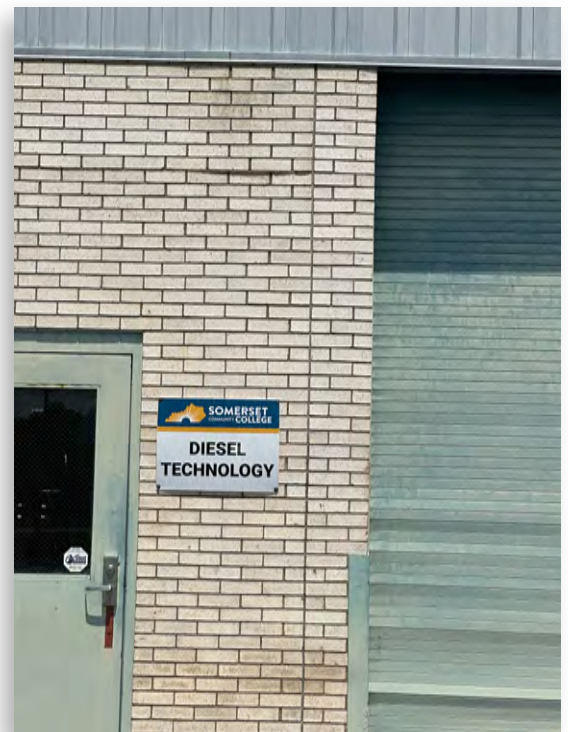
This photo of the parking lot side of the 1975 addition shows the expected expansion joint where the stresses in a brick wall are likely to cause damage to the bricks. However, this area again shows the issues with the relief angles 32" from the top of the brick (8 courses down) where the mortar has popped out of the joint. This issue with the relief angles is typical on all sides of the building.

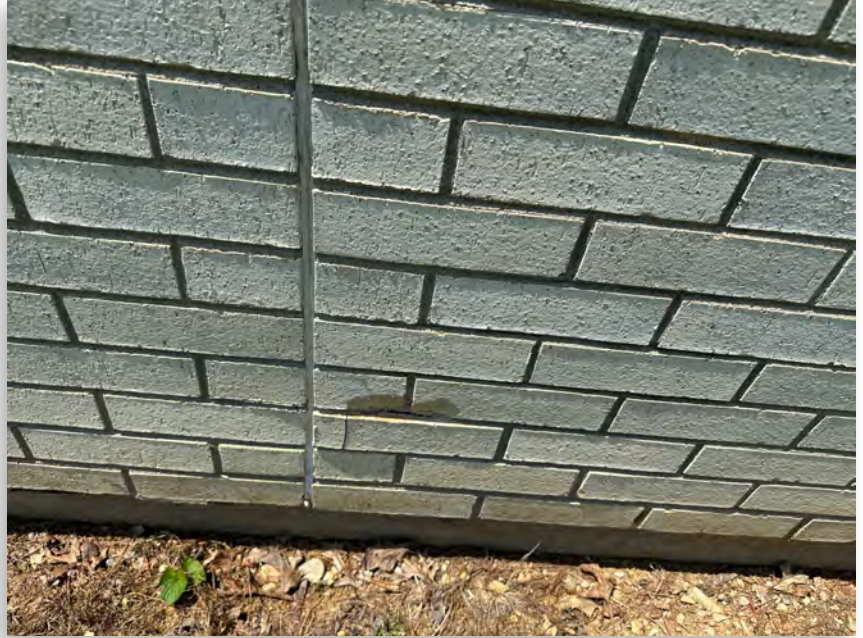
Even with properly located expansion joints, the expansion and contraction in the building is still causing bricks to spall and break. The image at right shows a broken brick on the right side of the expansion joint and two bricks above it with spalled faces.

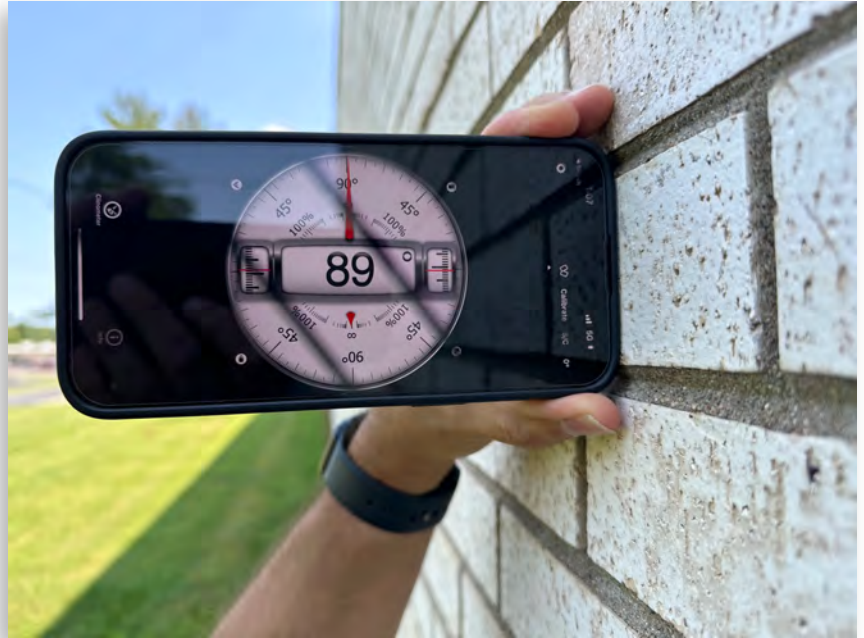
WPa attempted to photographically document the apparent bulging in some walls but were unable to make it apparent. Here, a level shows that the wall is slightly leaning outward.

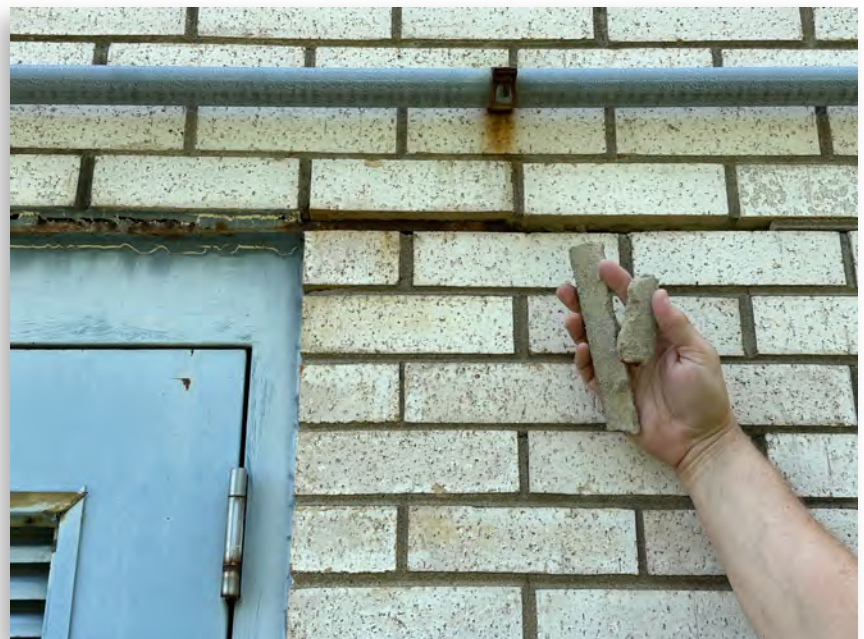
This mortar joints are so deteriorated that the mortar can be easily removed by hand at lintels and relief angles. In the empty mortar joint the rusted lintel is clearly visible.

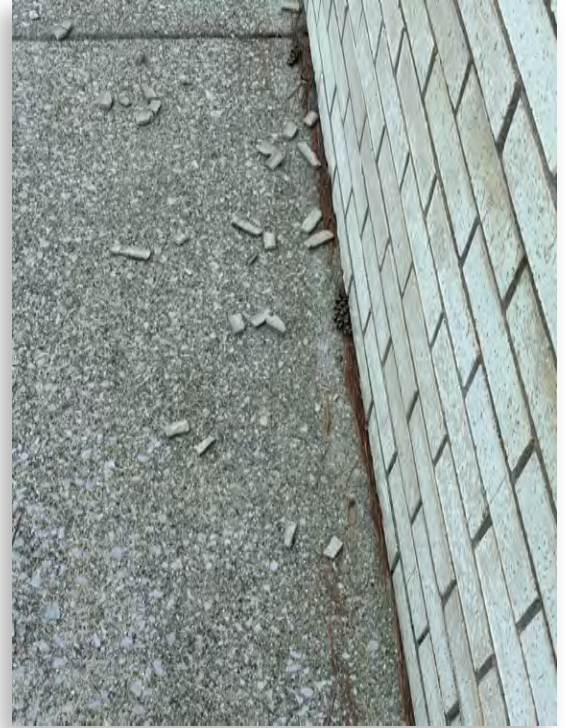
In the same area as the previous image, WPA found numerous fragments of mortar joints scattered on the sidewalk.

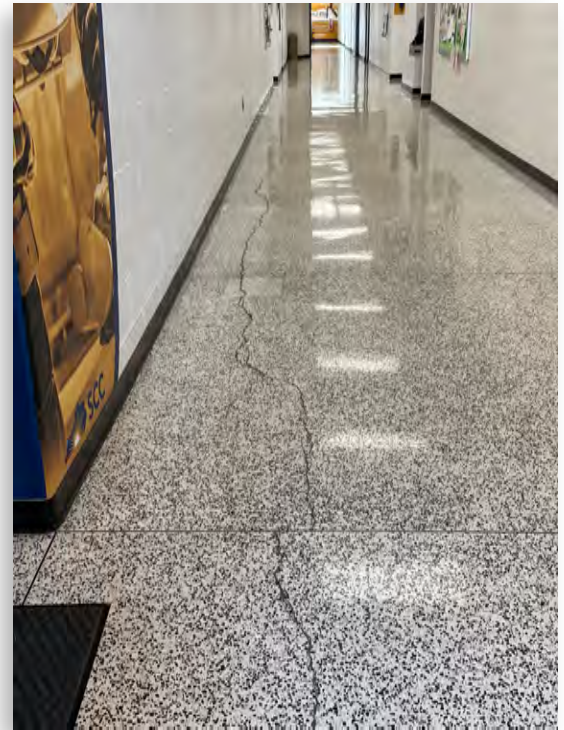
The main corridors in the 1971 building are terrazzo. The crack shown here runs the majority of the way down the wall separating the office/classroom spaces on the right from the open shop areas on the left. The building appears to be divided structurally along this line and there is an expansion joint on the roof directly above. This wall on the left side of the image is a bearing wall and has experienced some settling since the building was constructed.

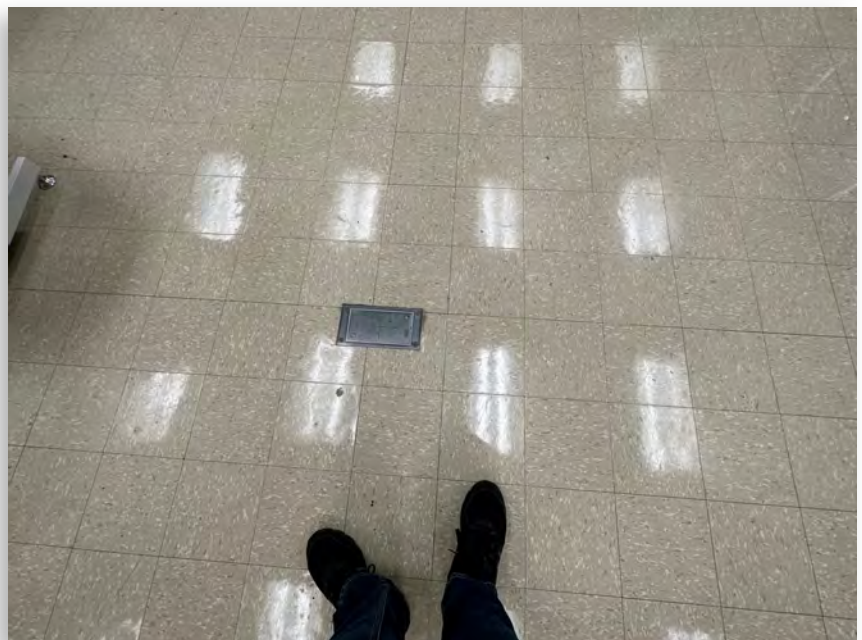
The VCT flooring in the Esthetics area consists of 8" x 8" tiles. These tiles are typically associated with asbestos products and should be tested before any work in this area begins.

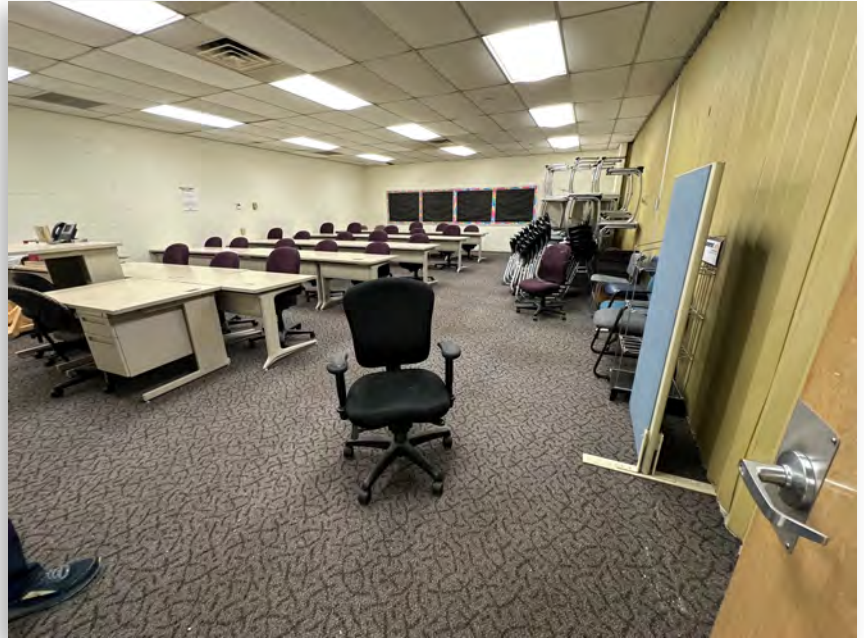
The interior finishes in many areas are dated. Ceiling tiles are sagging and discolored from the humidity and age. The accordion wall panel on the right of this image is in particularly bad shape. Many classroom spaces have no windows and poor lighting. Carpets are wall to wall and hold on to mildew smells, stains and wear in many areas.

Most interior finishes need to be updated. Some elements like the acoustical ceilings are in such poor shape (sagging, discoloration, etc.) from exposure to humidity that they should be completely replaced. There are a variety of floor finishes throughout the building and many of them are dated

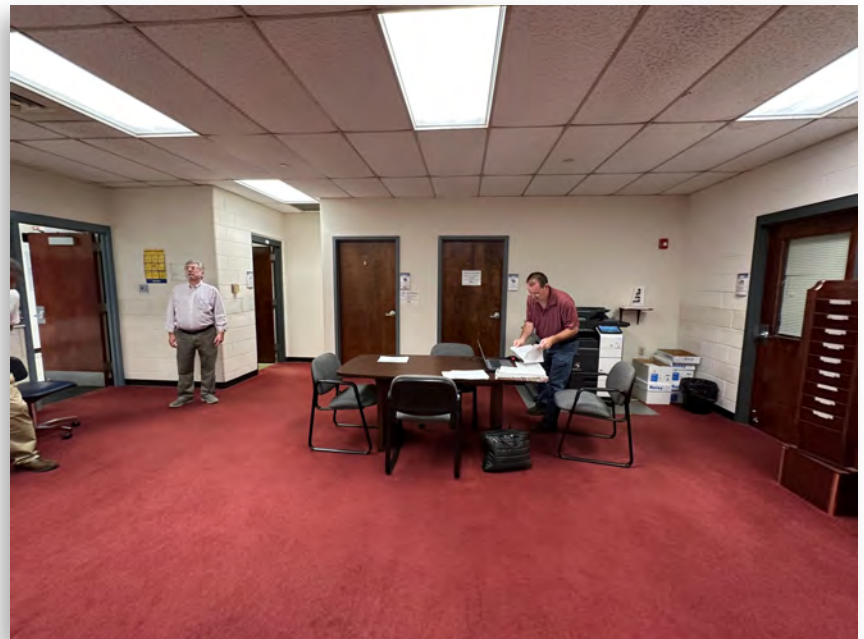
This area in the original building was renovated during the addition project in 1975. However, the sagging acoustical ceiling tiles, cut-pile carpets, and dated colors and finishes show the age of the space.

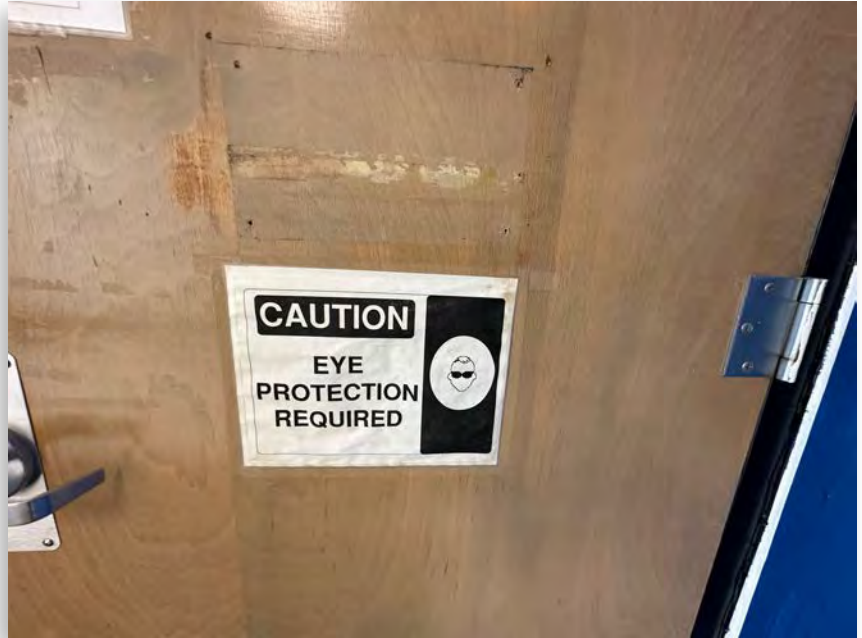
The interior doors on many spaces are in bad shape. Some doors are showing the effects of changes in humidity over 45 years, others have obvious water damage, and some are repurposed doors or doors that have been damaged through use. Interior doors need to be replaced to provide a consistent look and to ensure the right door is used for the space it serves.

Interior doors should be replaced with new solid-core wood doors with new hardware and locks at all locations where a solid-core wood door is appropriate. The shop areas where the interior environment is variable due to garage door operation, cleaning and other activities should be equipped with new, galvanized, hollow-metal doors. Most interior frames are likely in good shape but where there has been water damage to doors in shop areas, new, galvanized hollow-metal frames are also recommended.

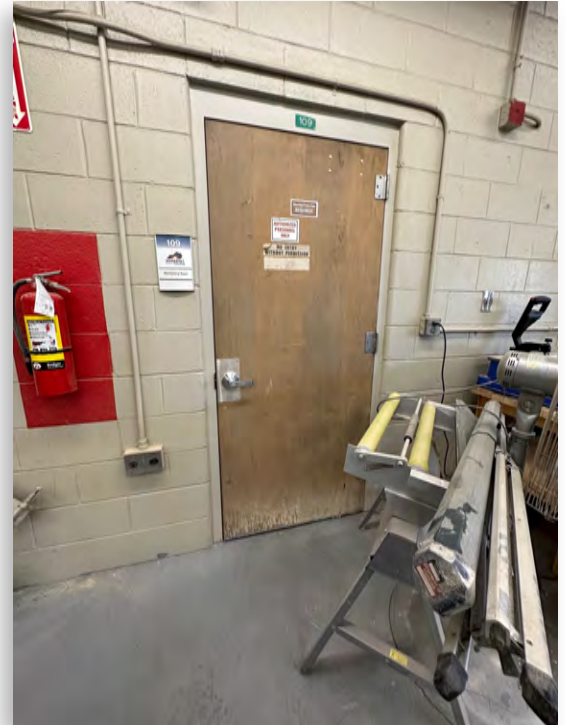
This door, in a shop area, has obvious water damage at the bottom. This is another example of doors that are inappropriate for their environment. Doors in areas like this should be hollow-metal and galvanized to protect them from elements.

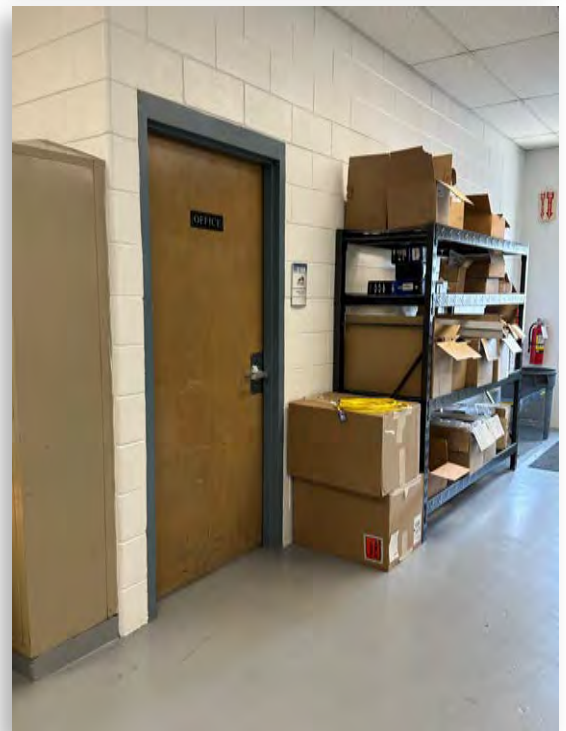
This photo shows another door in an area that should have had a hollow metal-door based on the use of the space. This door in the autobody shop is also showing water damage at the bottom edges.

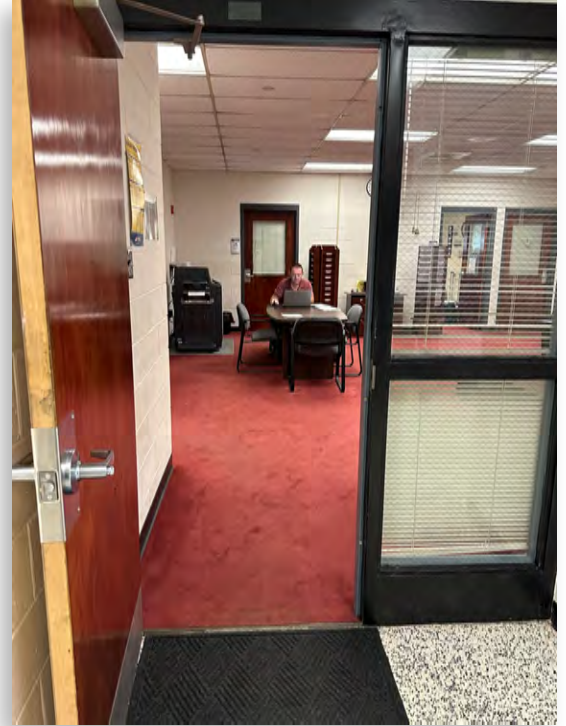
Even in areas that are less exposed to the elements and physical abuse, the doors are showing their age. This door into an office area has several chips in the latch-side edge and the veneer is starting to pull away in spots. This photo also shows the condition of the carpet in the offices at the door threshold where no transition strip was installed – or has been damaged and removed.

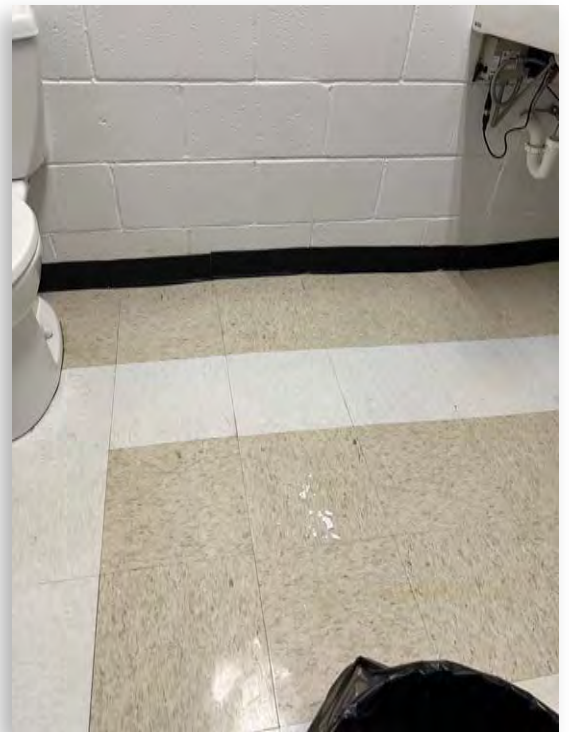
This unisex restroom in the faculty lounge was converted from a trashcan washing room that was only accessed from the outside and a janitor's area in the original kitchen off the cafeteria. There is a considerable deformation in the floor where a CMA wall was removed. At the time of WPA's visit to the site there was also an active leak in the ceiling of this room - water can be seen on the floor in the photo.

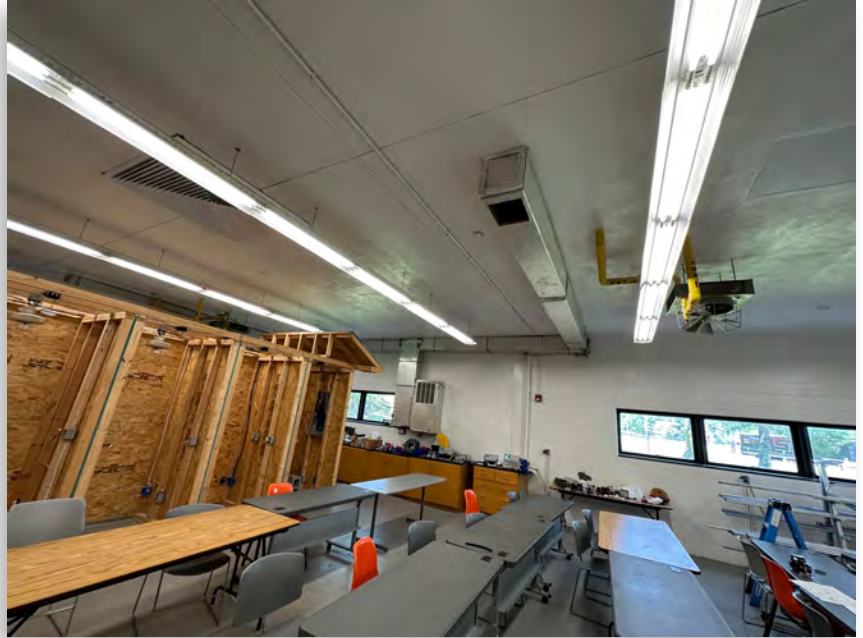
The photo shows the interior of the electrical shop and the surface mounted unit and ductwork connected to the condenser outside through the window. Shop areas were not designed with air conditioning originally. They were designed for heat only which was provided by a steam radiator with a fan (one can be seen on the ceiling to the right of the light fixture (yellow pipes) The A/C has been added later.
