Final Report for

## KCTCS - LAUREL SOUTH CAMPUS FEASIBILITY STUDY SOMERSET COMMUNITY COLLEGE

KCTCS Somerset - 235 S Laurel Rd  
London, Kentucky 40744

1 September 2023

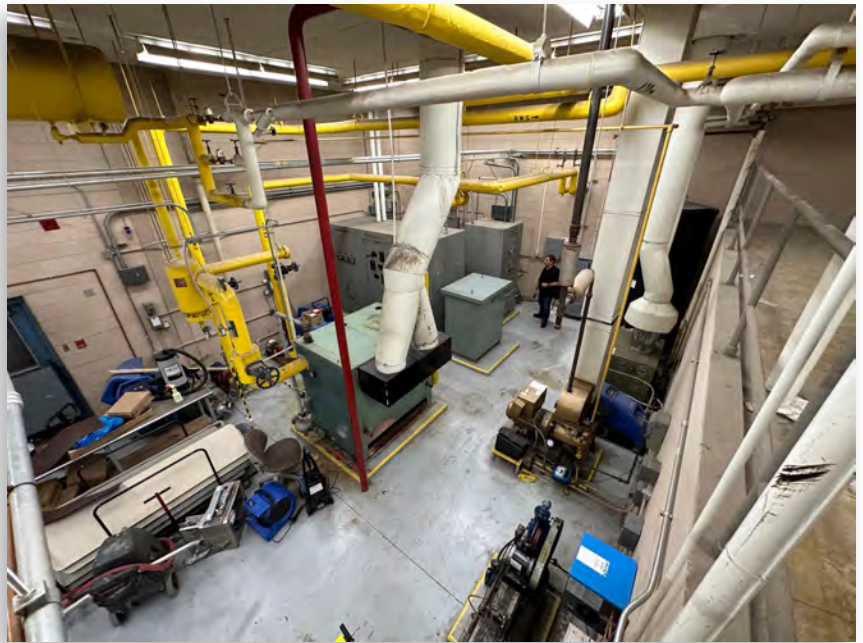
An overview of the mechanical room in the 1975 addition from the mezzanine over the restroom, showing the boilers, and the original switchgears in the background. The yellow piping supplies hot water to radiators with fans in the shop areas.

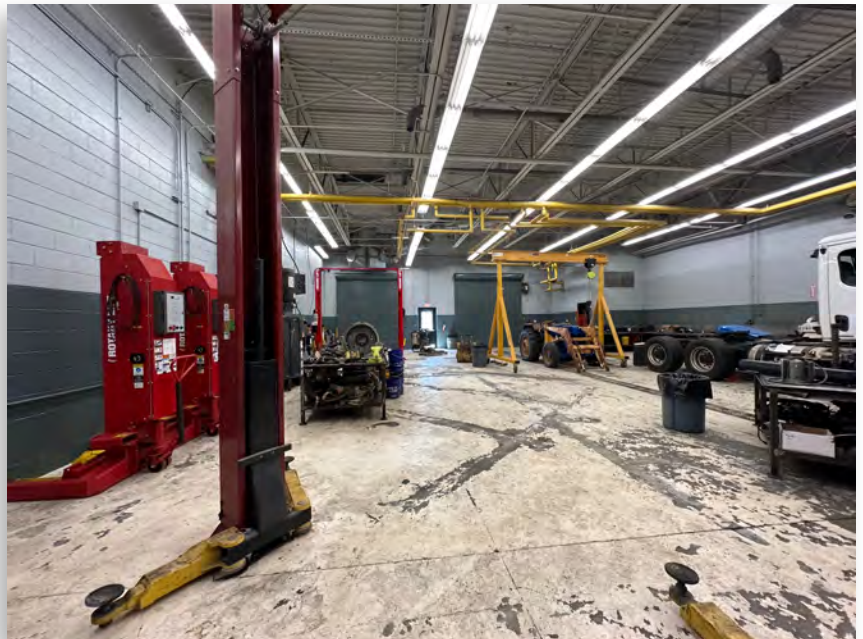
The Diesel Technology Lab, however did not appear to have any exhaust extraction systems. These shop spaces are provided with only heaters (fan-powered radiators) and are not conditioned spaces. The office spaces and classrooms have been equipped with a variety of A/C solutions from PTAC units to residential window units to provide cooling in these areas.

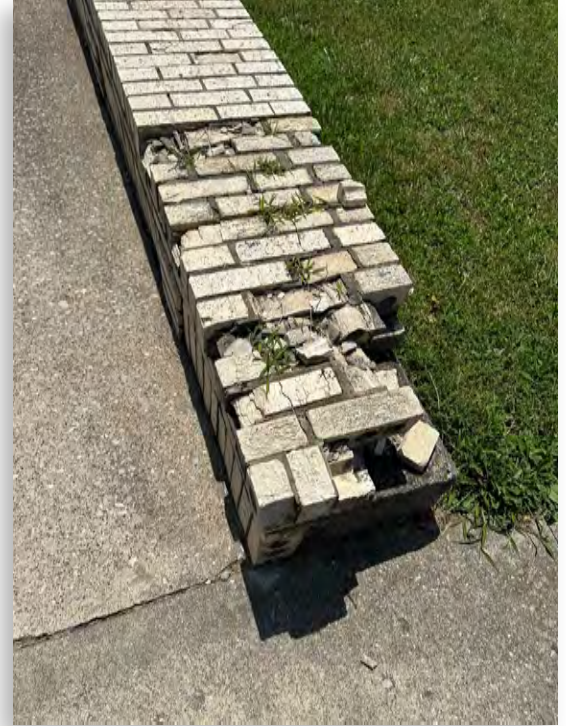
Brick landscape walls that are in bad shape need to be repaired or rebuilt depending on whether they are retaining walls or simply decorative like this one at the right.

WPa recommends repairs and improvements to all landscaping walls and fences around the building. This will add to the much-needed sense of place at the Laurel South Campus.

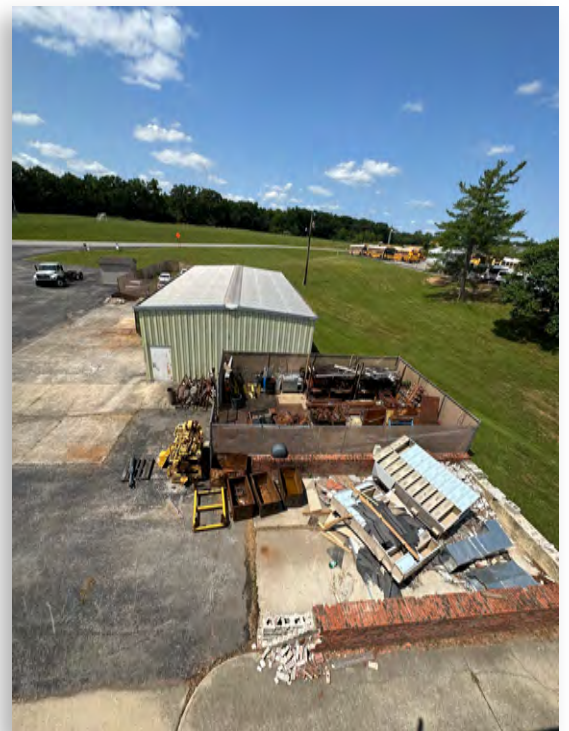
This view of the maintenance shed from the roof of the 1975 addition shows the need for new fencing and walls as well as the condition of the asphalt parking lot. The building itself seems structurally sound but could use a new metal skin and some improved shelving and storage inside as well as upgrades to insulation were needed and any heating units.

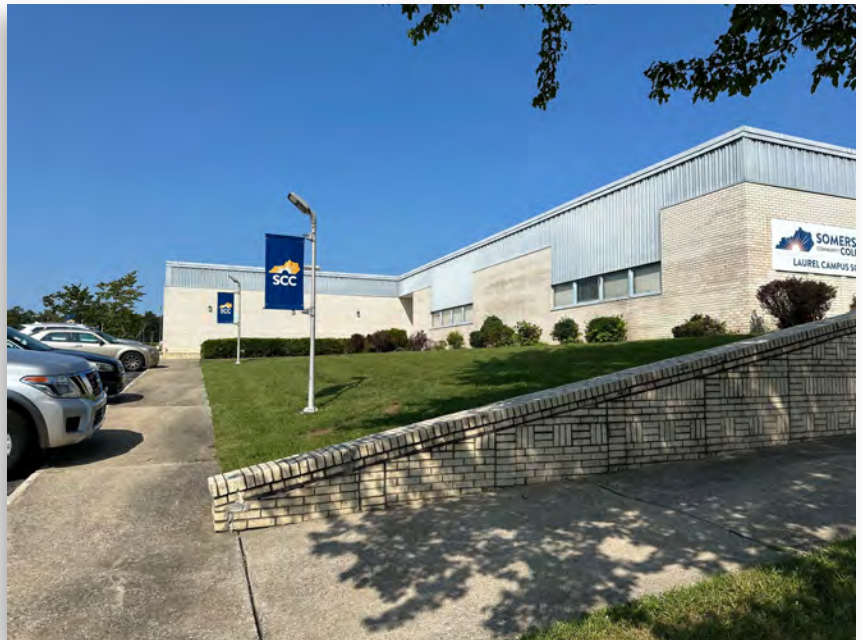
This retaining wall along the sidewalk leading to the main entrance is in disrepair. The wall has cracked and spalling bricks, damaged mortar joints and significant discoloration as it leads visitors up to the lobby.
