Department of Environmental Conservation

January 13, 2023

Subject: **City of Saint Paul Bulk Fuel Storage Facility Oil Discharge Prevention and Contingency Plan, ADEC Plan #: 20-CP-2018; Inspection Results**

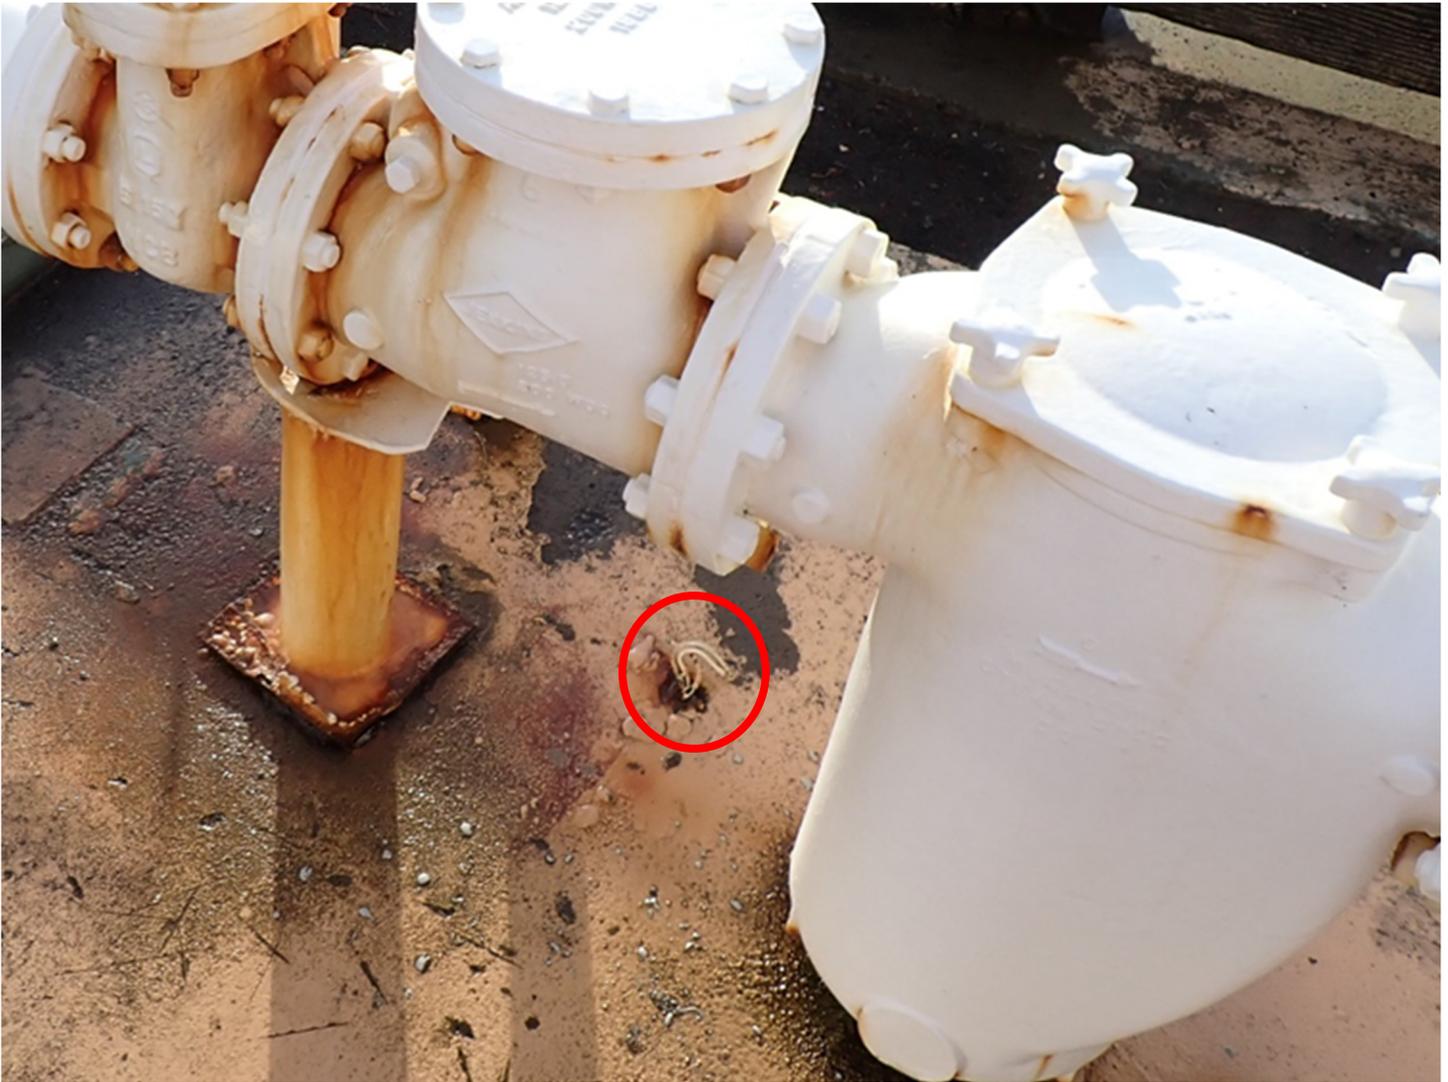
Photo #1

During the field inspection, I saw what appeared to be an unsealed electrical conduit penetration in the marine header secondary containment. Secondary containment area (SCA) breaches and damage could result in spilled oil escaping the SCA. This is a repeat area of concern from the department's September 2016 inspection. (See photo example #1)

Description: Containment breach beneath marine header where wiring comes through (Open deficiency from 2016 inspection. Facility representative initiated repairs the same day. Awaiting photographic evidence of completion of repairs)

Action: City of Saint Paul employees initiated repairs to the SCA while department staff was still on the island. Complete repairs and send photographic evidence of the completed repairs to the department.

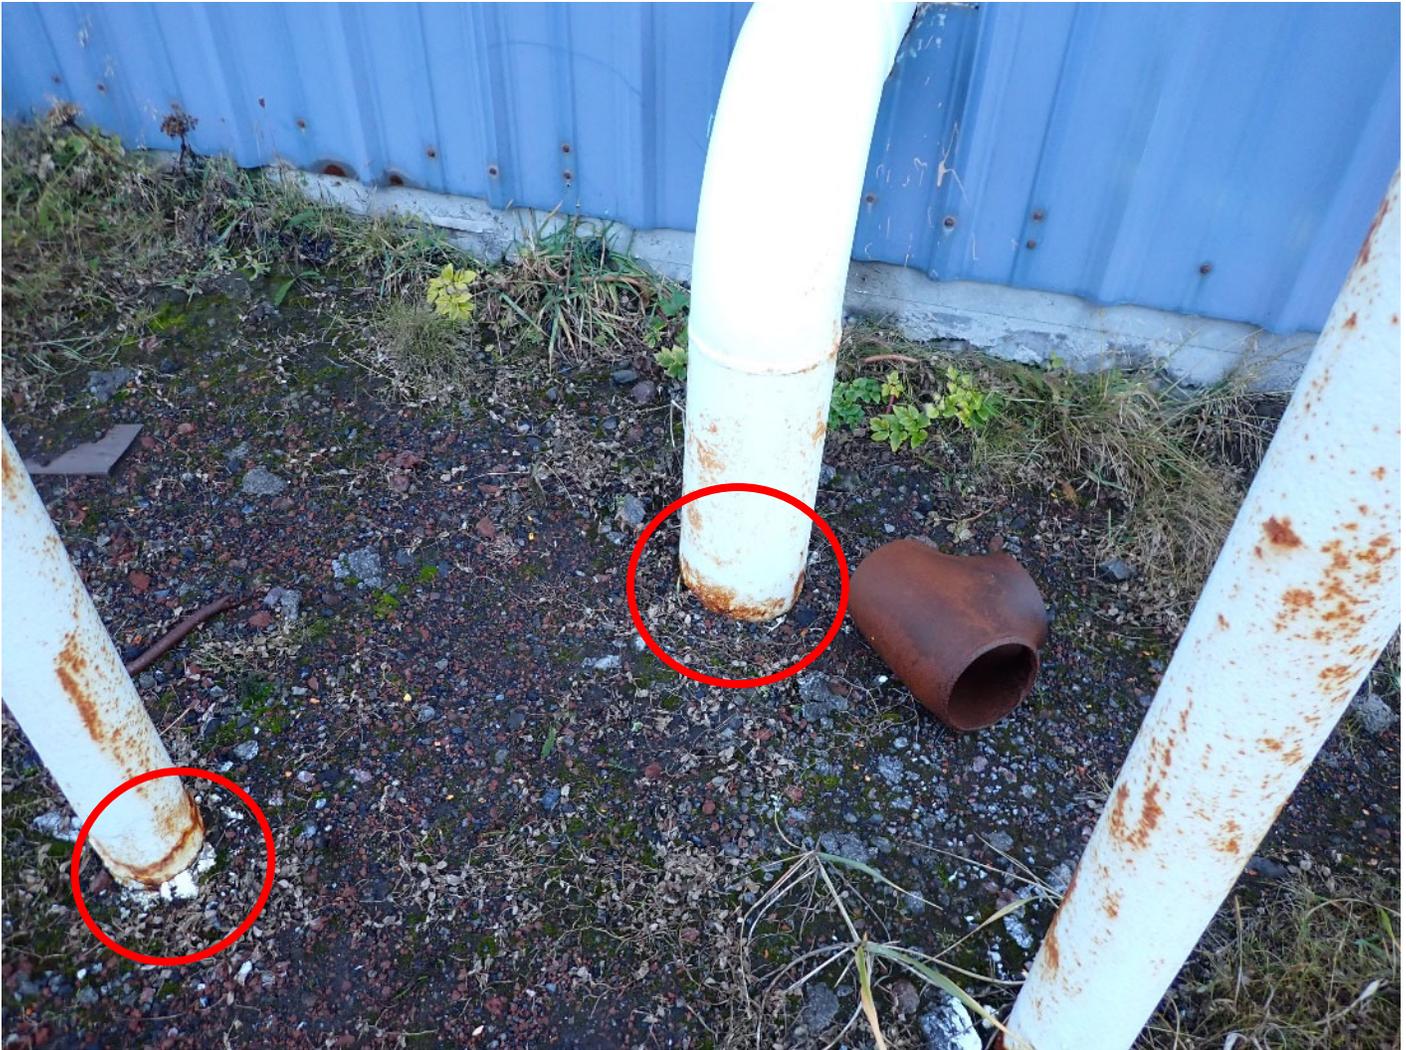
During the inspection it was noted that soil interface wrappings appeared to be in poor condition or missing on the 4-, 6-, and 8-inch pipelines located throughout the facility. Please be reminded that the American Petroleum Institute (API) 570 section 3.42 defines a soil-to-air interface as "an area in which external corrosion may occur on partially buried pipe. The zone of the corrosion will vary depending on factors such as moisture, oxygen content of the soil, and operating temperature. The zone generally is considered to be from 12 inches (305 mm) below to 6 inches (150 mm) above the soil surface. Pipe running parallel to the surface that contacts the soil is included as well." This is a repeat area of concern from the department's September 2016 inspection. (See photo example #2).

Photo #2
Photo File Name: PA110370.jpeg
Date of Photo: 10/11/22
Photographer: Howard Minor
Description: Soil-to-air defects identified on facility piping
(Open deficiency from 2016 inspection)

Action: The department requires a written corrosion control plan and timeline to repair the piping soil-to-air interfaces defects identified during the inspection. Establishing and adhering to an aggressive corrosion control maintenance program is crucial for protecting the facility against possible corrosion-related pipeline hazards. The department highly encourages the City of Saint Paul to consult with your Engineering Firm and your Cathodic Protection Testing Company for guidance on resolving the piping soil-to-air interface wrapping applications and any other cathodic protection concerns.

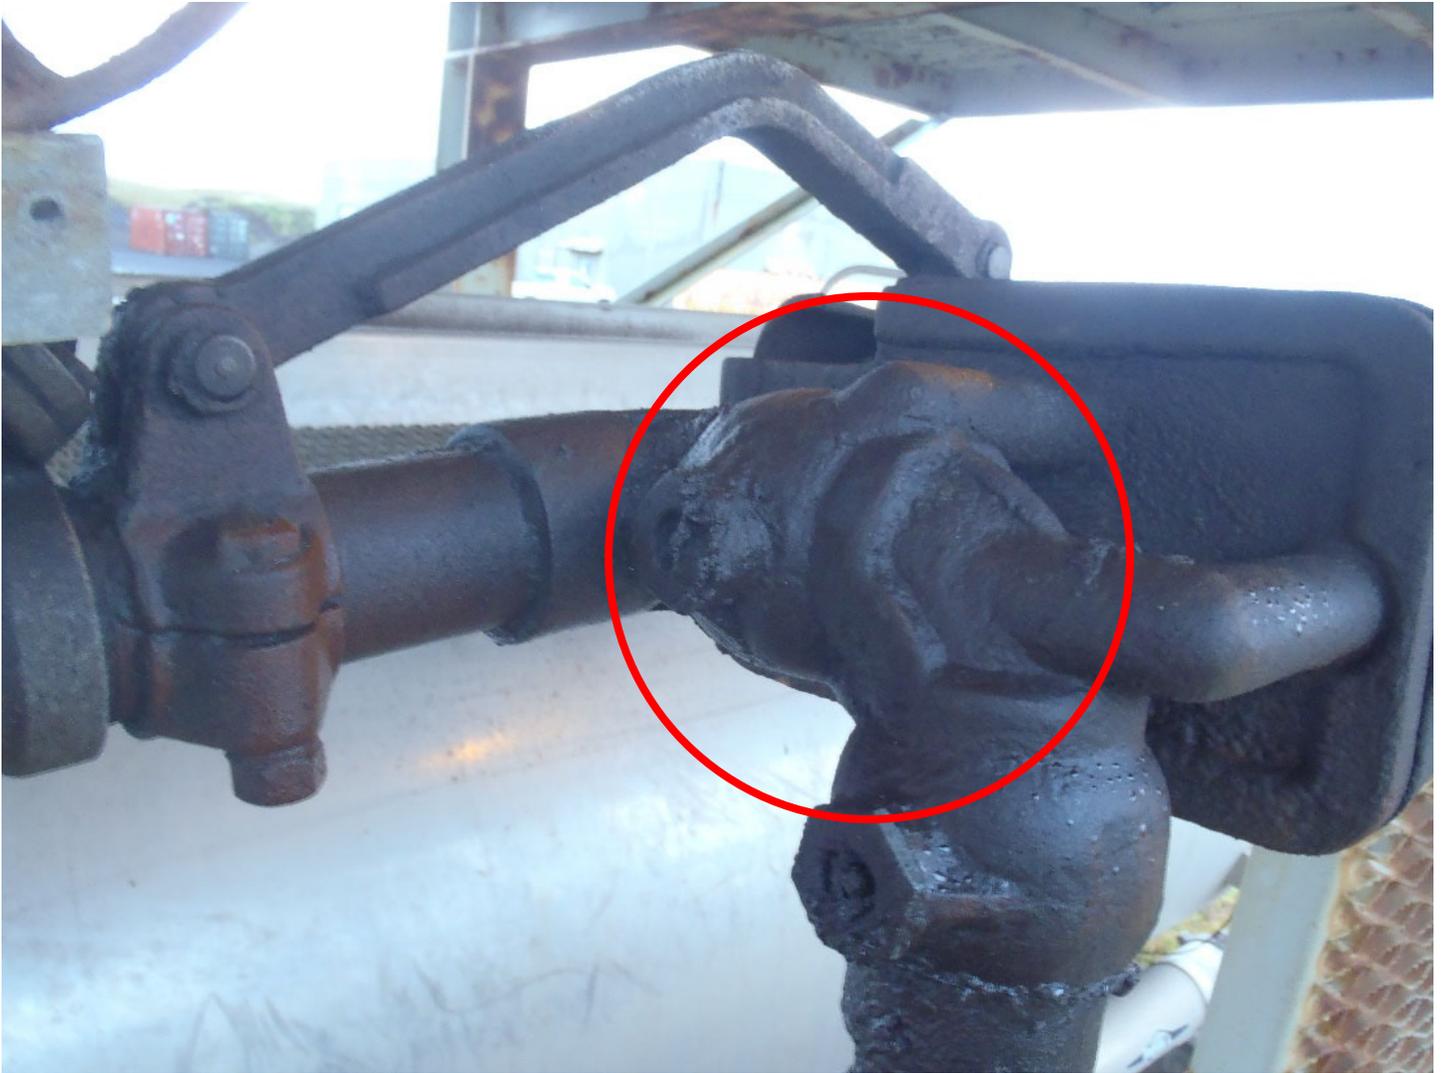
Photo #3

1. During the inspection I observed what appeared to be a leaking joint on the tank truck loading arm piping. A City of Saint Paul employee stated that a grease wrapping served as a temporary fix and is used to keep the joint from actively leaking. Recommend making repairs if possible and otherwise maintaining keen awareness of this issue. If City employees recognize active leaking from the joint in the future, a replacement of the arm should be considered to prevent a potentially significant fuel spill. (See photo example #3).
2. During the inspection City employees noted that the emergency stop for the tank truck loading arm does not work. It is recommended that the City of Saint Paul make repairs so that all engineering safeguards put into place for this system function as designed. (See photo example #4).

Description: Leaking joint on the tank truck loading arm. City of Saint Paul employees stated that a “grease wrap” serves as a temporary fix to prevent fuel from leaking.

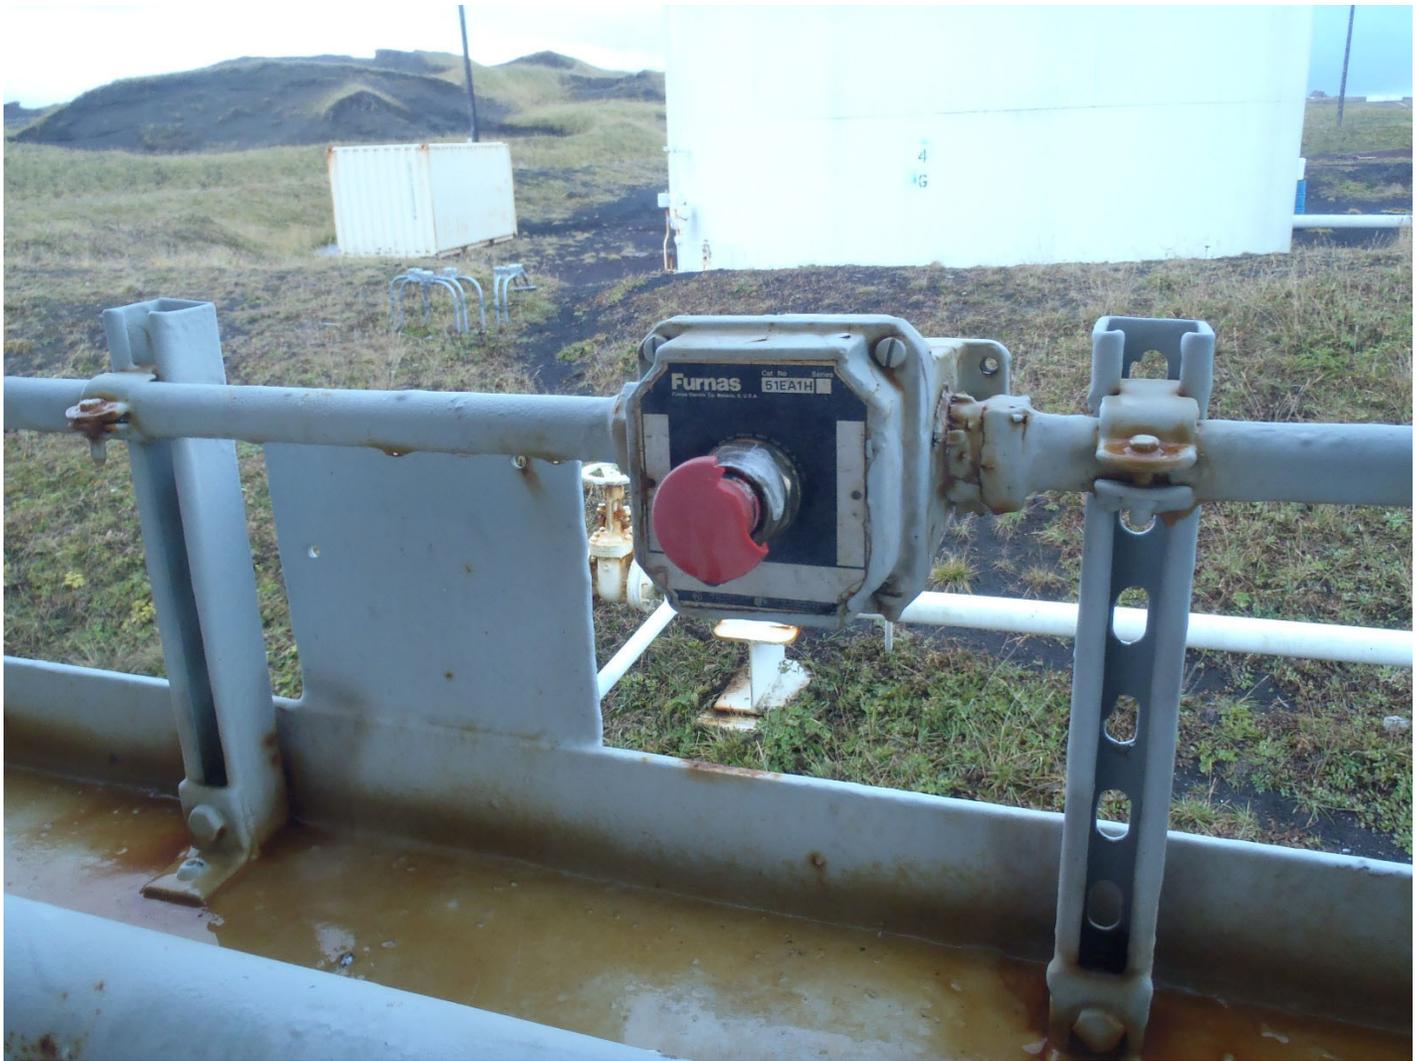
Photo #4

Description: During the inspection a City employee stated that the emergency stop for the tank truck loading area did not work.
