**API 653 In-Service Inspection Report:
City of Saint Paul Bulk Fuel Storage Facility**

Tank #6

September 24 - October 2, 2023

Integrity Environmental LLC

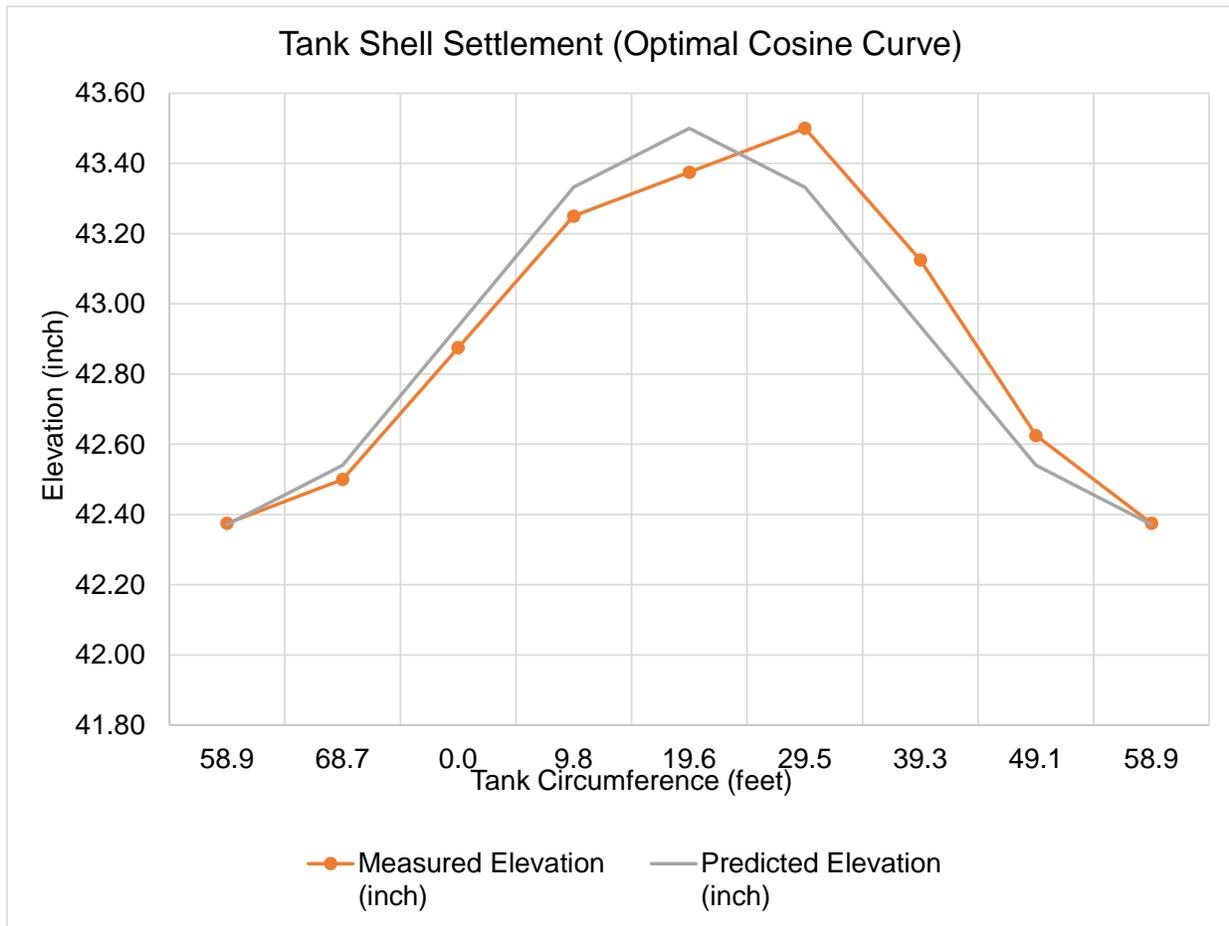
Graph 3-1 Foundation Settlement Evaluation

The settlement evaluation for the tank is planer or roughly approximates the shape of a cosine curve. The evaluation of this “out-of-levelness” or settlement, utilizing the criterion for “out-of-plane distortion” as described in API 653 Annex B, indicates that the settlement is within the acceptable limits.

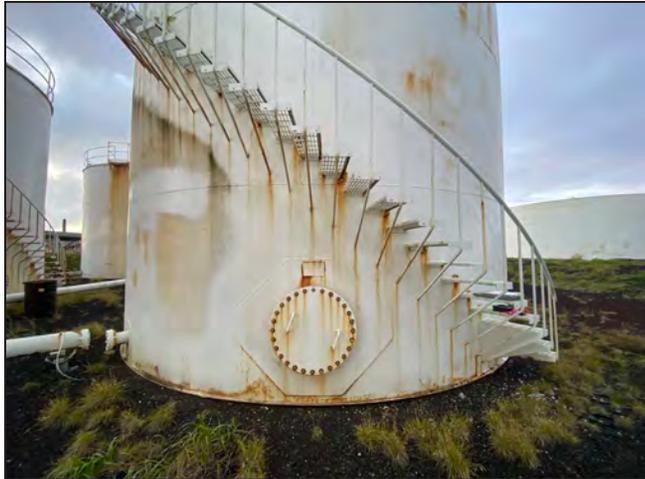
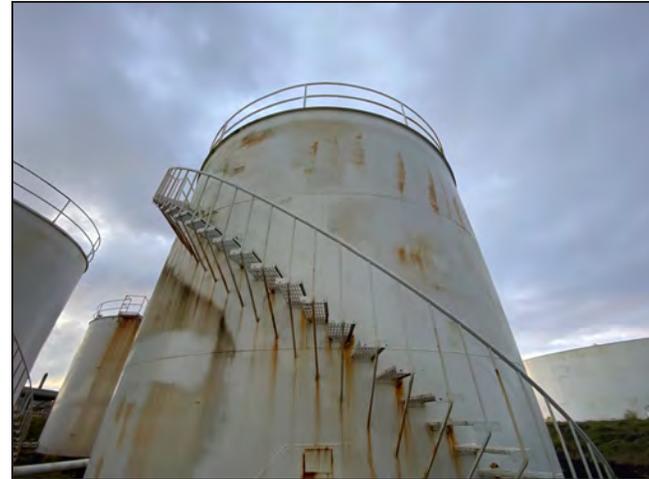
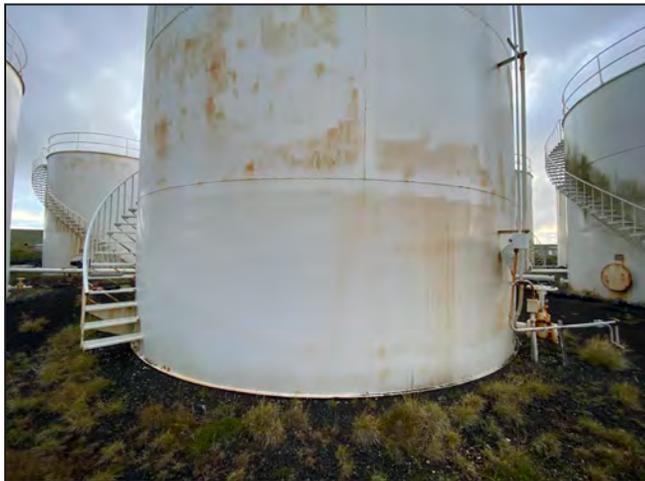
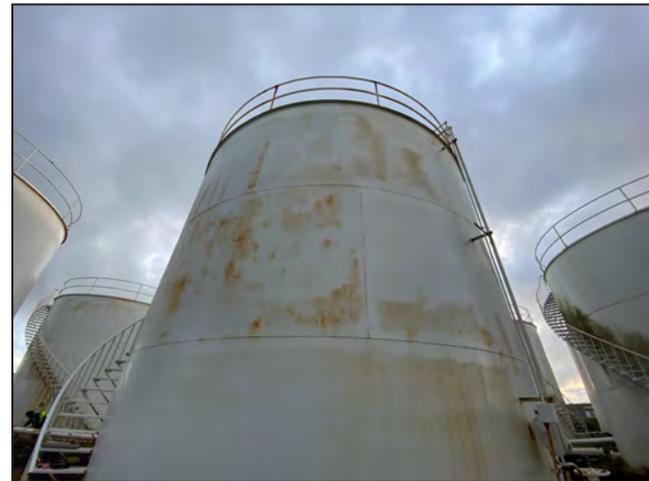
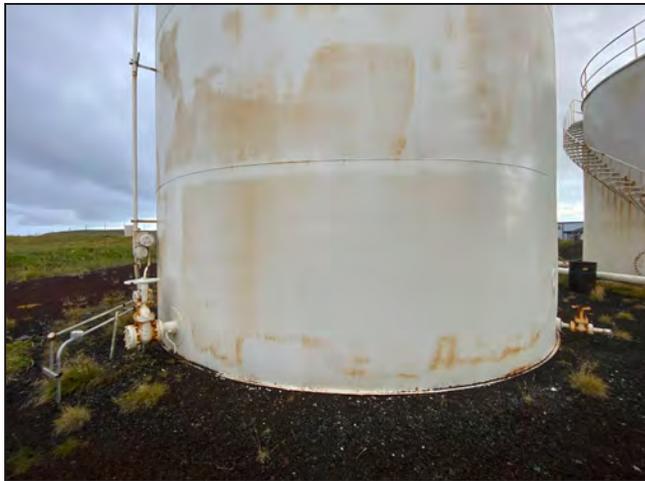
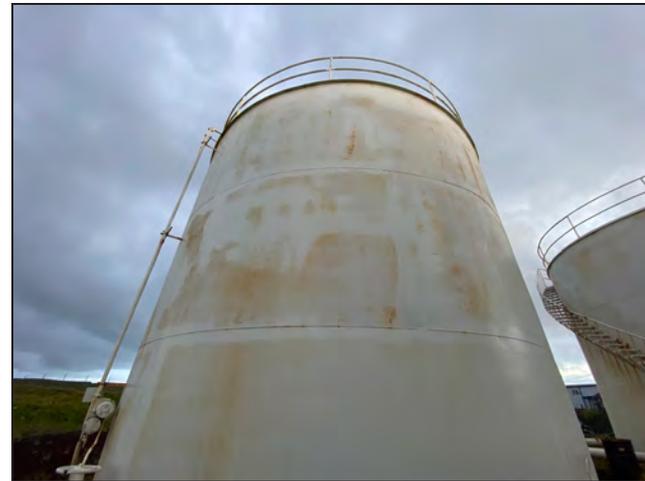
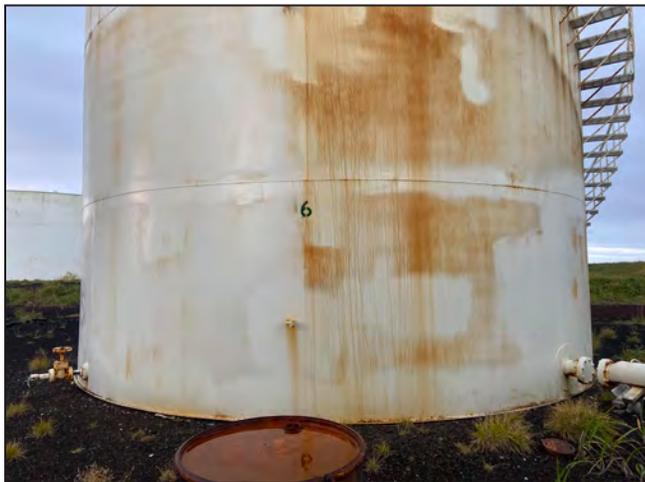
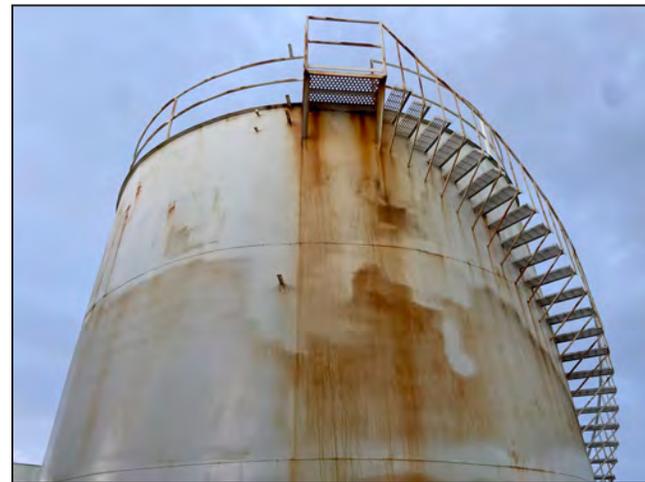
High Priority:	
Labeling	<ul style="list-style-type: none"> ● Product, tank capacity, safe fill height, tank gauging heights, OSHA, and NFPA 704 labels were not observed on tank. Refer to Appendix A, photo no.(s): 1 – 8. <ul style="list-style-type: none"> ○ Add product, tank capacity, safe fill height, tank gauging heights, OSHA, and NFPA 704 labeling onto the tank so they clearly communicate the hazards related to the contents and fuel transfers. ○ Monitor and maintain labeling to make sure it is legible or replace as practicable.
Overfill Prevention	<ul style="list-style-type: none"> ● Unable to verify overfill prevention system was operational at time of inspection. Refer to photos: 16 – 18, 36, 40. <ul style="list-style-type: none"> ○ Verify and document the operation of overfill prevention system such as liquid level gauging and high-level alarm. ○ Repair/replace overfill prevention system devices and components, as necessary, to keep operational.

Moderate Priority:	
Shell and Shell Nozzles / Appurtenances	<ul style="list-style-type: none"> ● Moderate to severe coating failures with general surface corrosion were observed throughout. Refer to Appendix A, photo no.(s): 1 – 29. <ul style="list-style-type: none"> ○ Areas of coating failures should be cleaned and recoated, as necessary, to prevent further deterioration of coating and mitigate corrosion. Coatings should be applied in accordance with industry standards. ○ Monitor and maintain acceptable condition of the coatings to prevent damage from the atmospheric conditions.

Photo 1: View of lower tank section at ~0 degrees.

Photo 2: View of upper tank section at ~0 degrees.

Photo 3: View of lower tank section at ~90 degrees.

Photo 4: View of upper tank section at ~90 degrees.

Photo 5: View of lower tank section at ~180 degrees.

Photo 6: View of upper tank section at ~180 degrees.

Photo 7: View of lower tank section at ~270 degrees.

Photo 8: View of upper tank section at ~270 degrees.

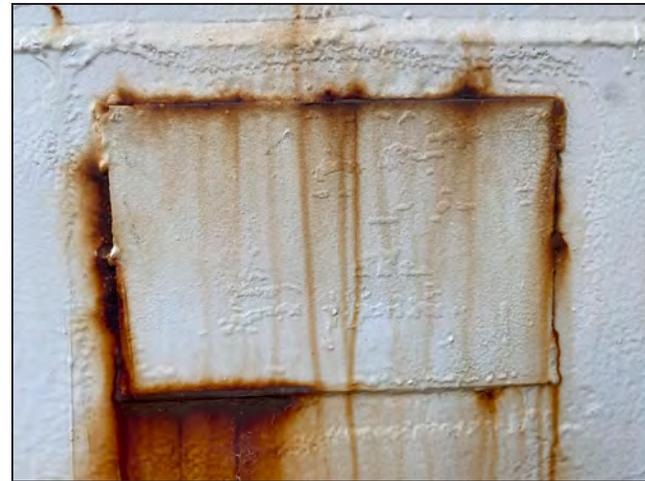
Photo 10: Detail view of nameplate (illegible).

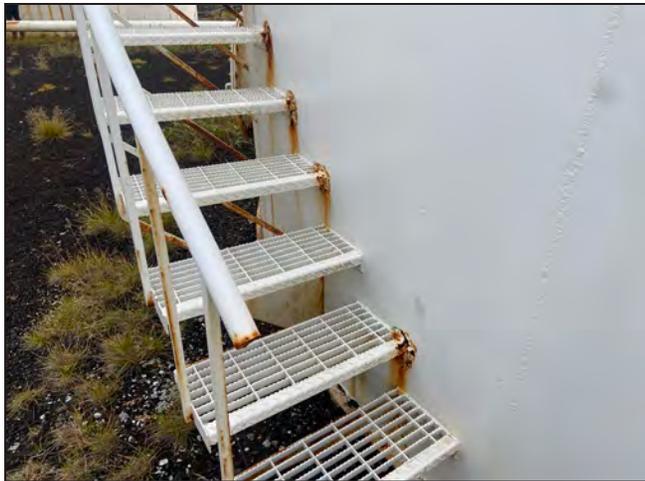
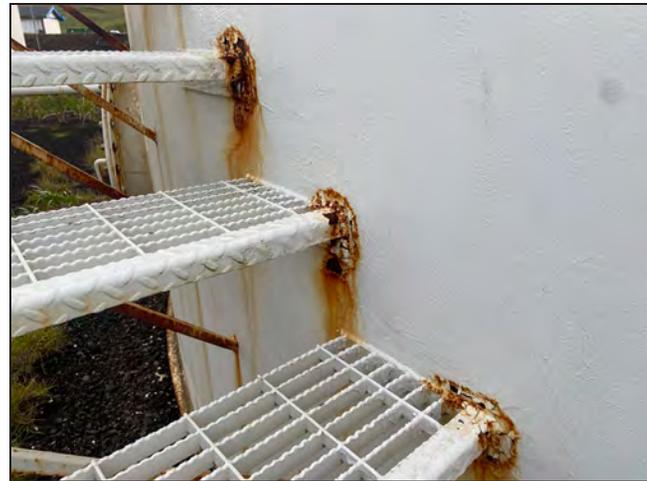
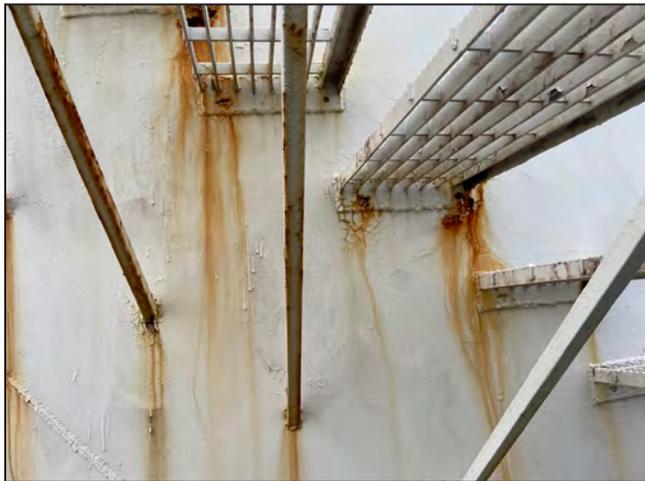
Tank Accessways	<ul style="list-style-type: none"> ● Moderate to severe coating failures with general surface corrosion were observed throughout. Refer to Appendix A, photo no.(s): 1, 2, 8, 13 – 15, 32, 54 – 56. <ul style="list-style-type: none"> ○ Areas of coating failures should be cleaned and recoated, as necessary, to prevent further deterioration of coating and mitigate corrosion. Coatings should be applied in accordance with industry standards. ○ Monitor and maintain acceptable condition of the coatings to prevent damage from the atmospheric conditions.

Photo 13: View of tank stairs.

Photo 14: Detail view of tank stairs.

Photo 15: Detail view underneath stairs.

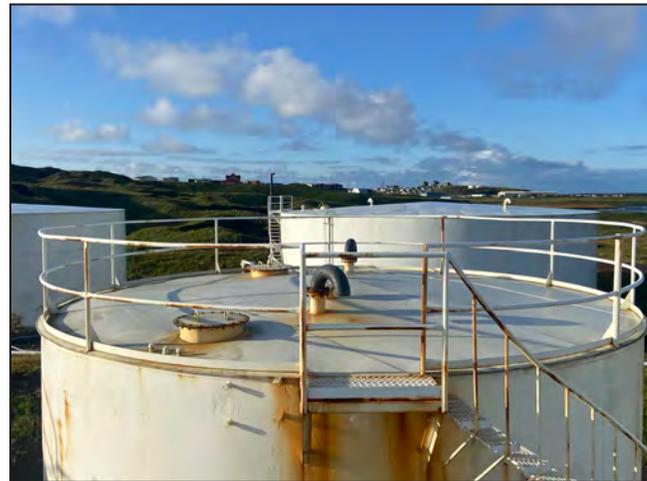
High Priority:	
Venting	<ul style="list-style-type: none"> ● No emergency relief venting was observed. Refer to Appendix A, photo no.(s): 32 – 35. <ul style="list-style-type: none"> ○ Install and document emergency relief venting per manufacturer design or engineering best practices. ○ No manufacturer tank drawing or design information was available to determine the form of construction that provides emergency relief venting. Emergency relief venting is required in the form of construction or device(s) to relieve excessive internal pressure in the event of an emergency, such as a fire. ● Both of the 6-inch atmospheric gooseneck vents were missing mesh screens to prevent bird entry. Refer to Appendix A, photo no.(s): 37, 38, 45, 46. <ul style="list-style-type: none"> ○ Verify and install a mesh screen per manufacturer sizing. ○ The screen should be a corrosion-resistant and coarse-mesh screen to prevent bird entry but not restrict airflow. ○ It is recommended that in areas where snow drifting or icing may be an issue the screen mesh should be appropriately sized to prevent clogging.

Moderate Priority:	
Fixed Roof and Fixed Nozzles / Appurtenances	<ul style="list-style-type: none"> ● Areas of standing water with biological growth observed on the roof plates around the perimeter. Refer to Appendix A, photo no.(s): 32 – 35. <ul style="list-style-type: none"> ○ Areas of coating failures should be cleaned and recoated, as necessary, to prevent further deterioration of coating and mitigate corrosion. Coatings should be applied in accordance with industry standards. ○ Monitor and maintain acceptable condition of the coatings to prevent damage from the atmospheric conditions. ● Moderate to severe coating failures with general surface corrosion were observed throughout. Refer to Appendix A, photo no.(s): 36 – 52. <ul style="list-style-type: none"> ○ Areas of coating failures should be cleaned and recoated, as necessary, to prevent further deterioration of coating and mitigate corrosion. Coatings should be applied in accordance with industry standards. ○ Monitor and maintain acceptable condition of the coatings to prevent damage from the atmospheric conditions.

Photo 32: Overall view of tank roof.

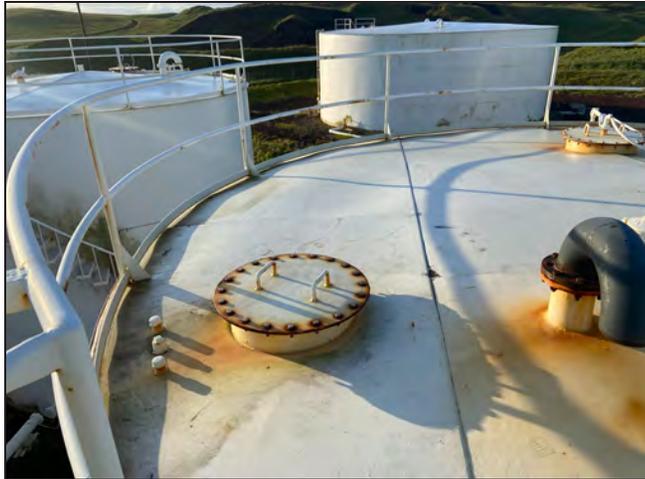
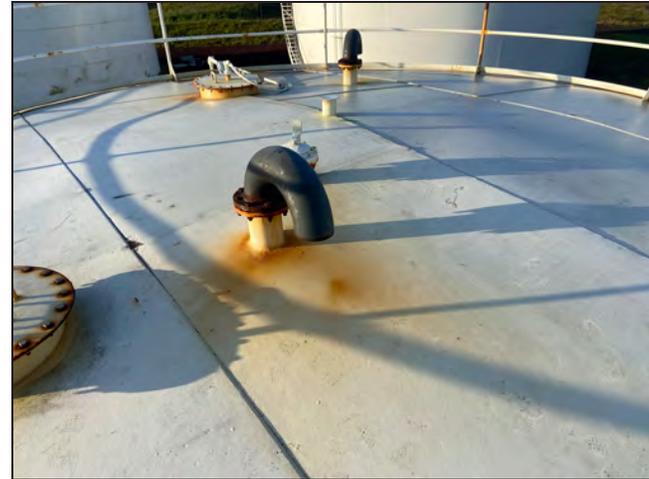
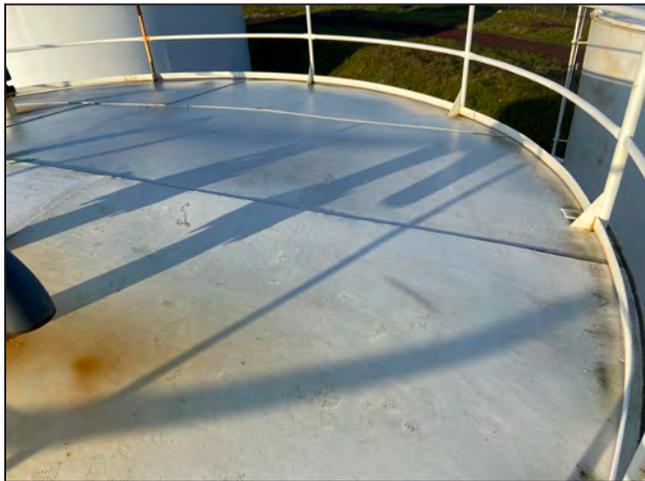
Photo 33: View of tank roof (left).

Photo 34: View of tank roof (center).

Photo 35: View of tank roof (right).

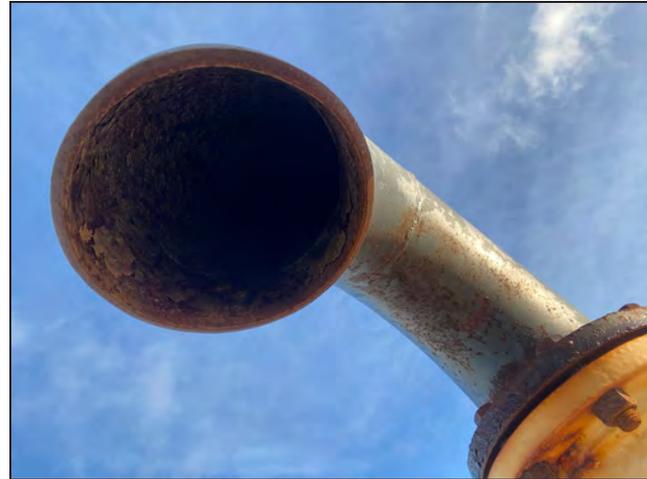
Photo 38: Detail view underneath gooseneck vent with no screen.

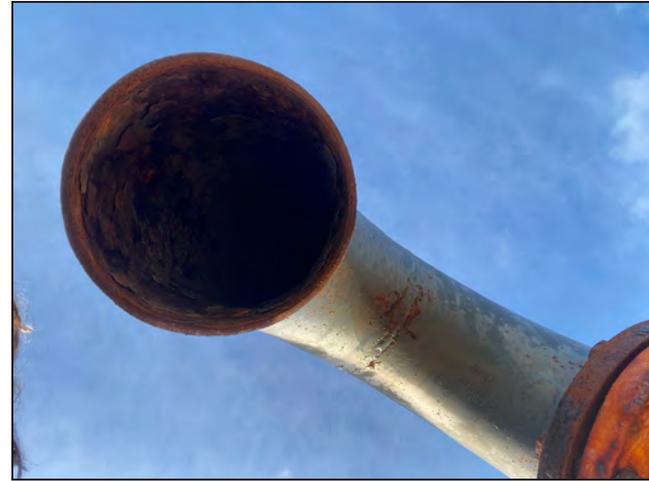
Photo 46: Detail view underneath gooseneck vent with no screen.

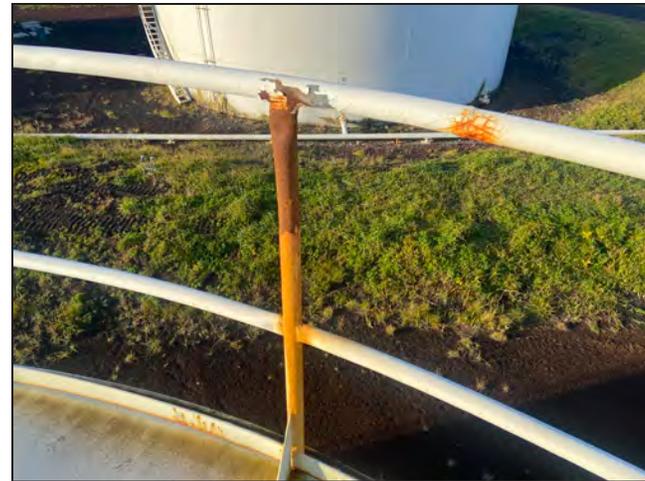
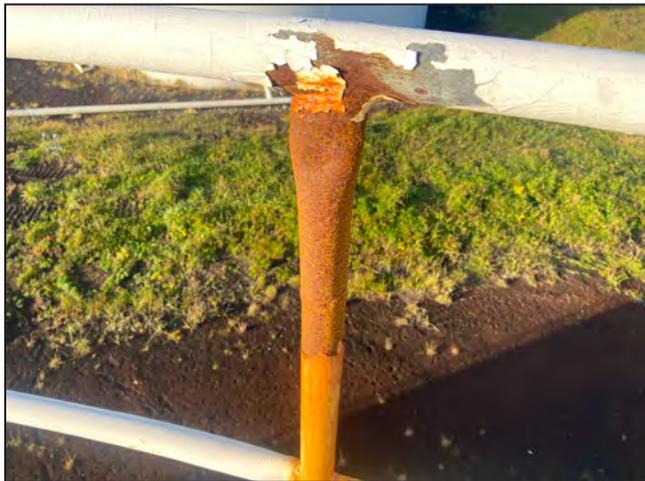
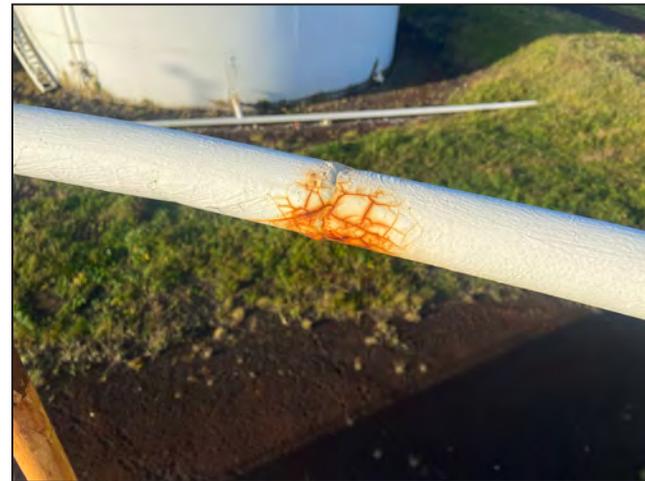
Photo 54: View of handrails.

Photo 55: Detail view of handrails.

Photo 56: Detail view of handrails.

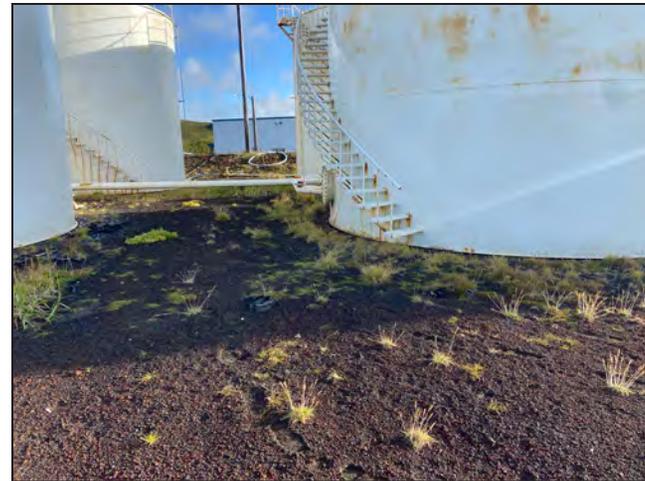
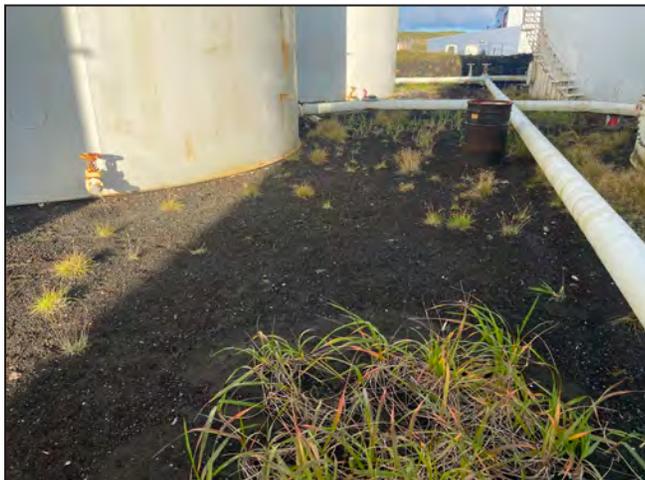
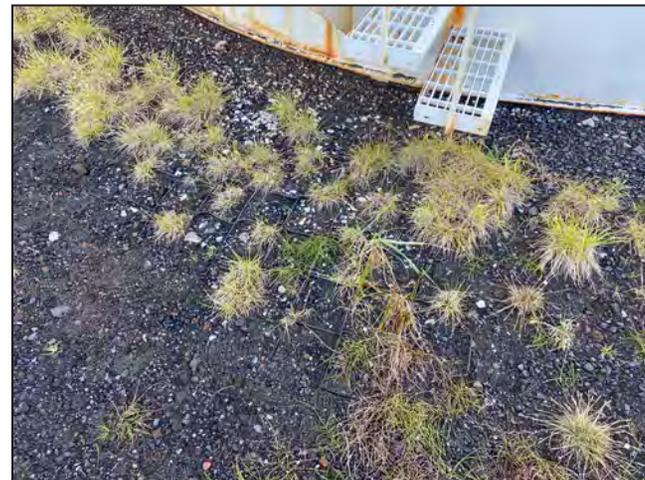
Low Priority:	
Secondary Containment Area (SCA) Liner	<ul style="list-style-type: none"> ● The SCA liner had visible areas where the top layer had erosion and areas of overgrown vegetation. Refer to Appendix A, photo no.(s): 58 – 60. <ul style="list-style-type: none"> ○ Remove overgrown vegetation as practicable. ○ Monitor SCA liner for wear and tear, then repair as practicable.

Photo 58: Overall view of tank foundation and earthen pad.

Photo 59: Overall view of tank foundation and earthen pad.

Photo 60: Overall view of tank foundation and earthen pad.
