TO: Phil Zavadil, City Manager, City of Saint Paul

FROM: Camille House, Inspector, Integrity Environmental LLC

DATE: January 30, 2023

SUBJECT: Cathodic Protection Testing for Buk Fuel Storage Facility in City of Saint Paul, Alaska

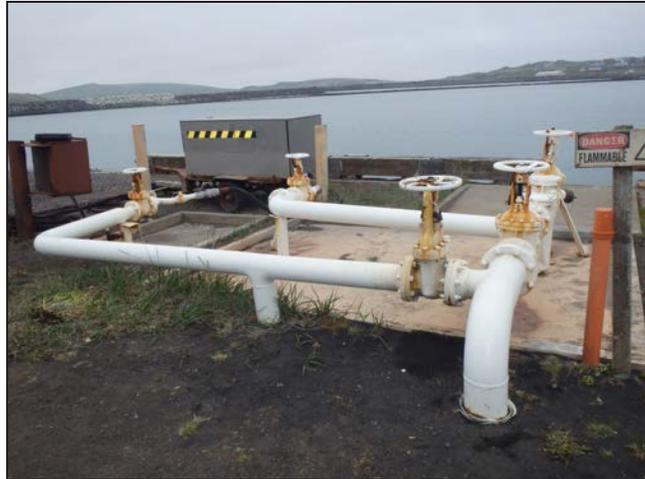
Photo 1: View of south dock testing location (orange test station on right).

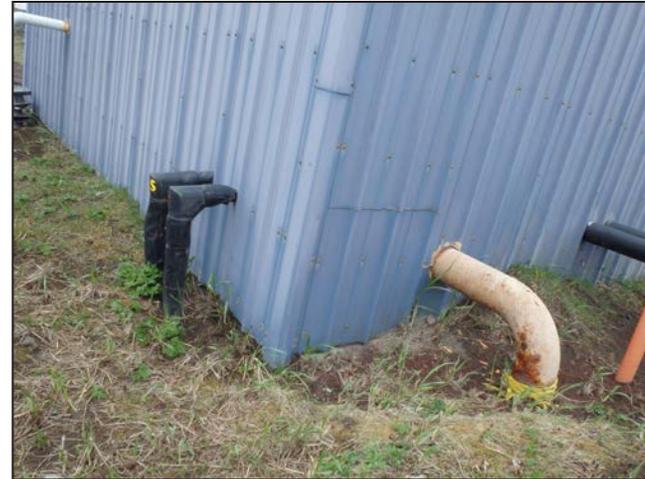
Photo 2: View of testing location behind pumphouse (orange test station on right).

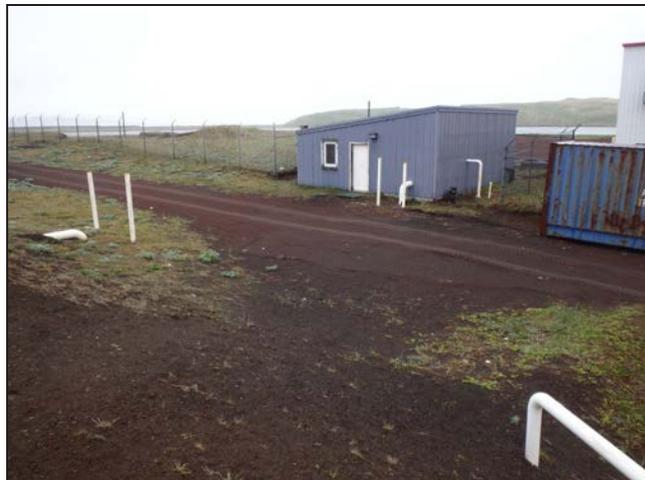
Photo 3: View of testing locations at the front of pumphouse and outside the tank farm.

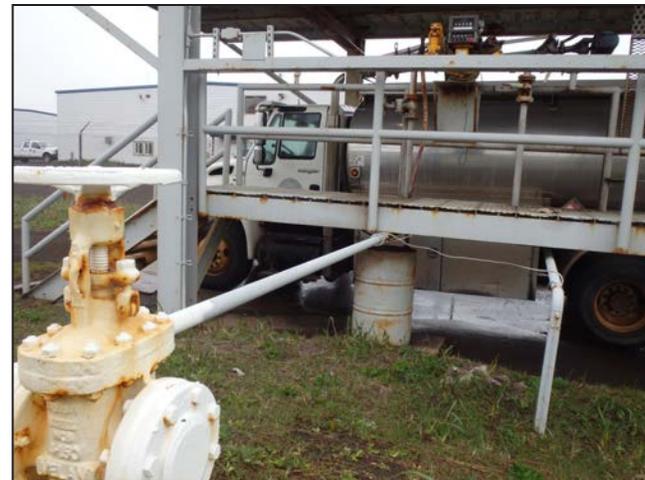
Photo 4: View of testing location at the truck loading area.

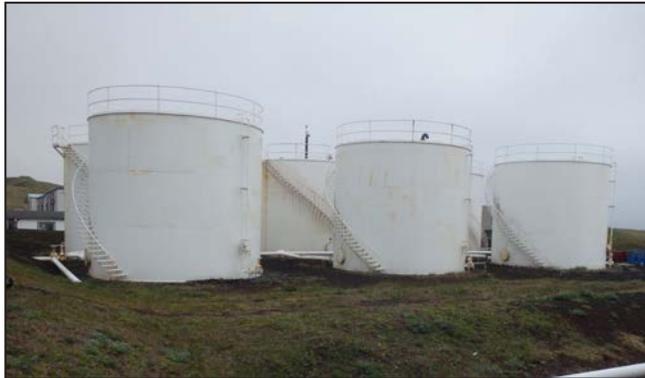
Photo 5: Overall view of the tank farm.

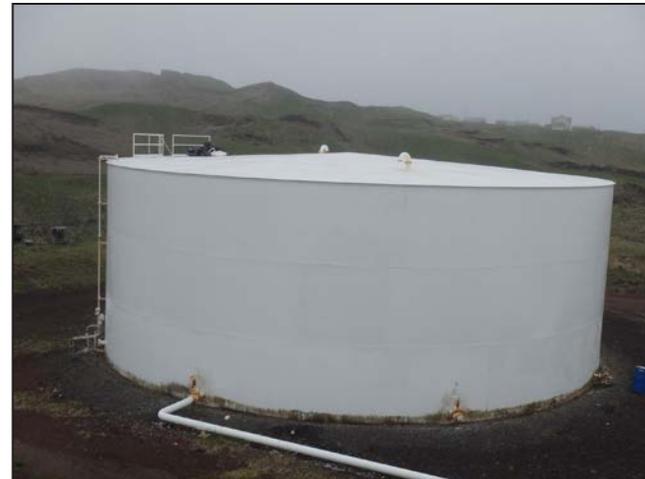
Photo 6: Overall view of tank #9.

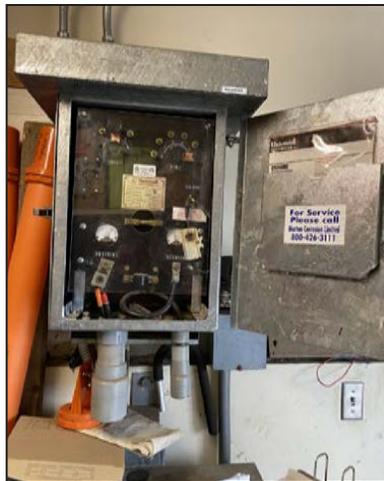
Photo 7: View of rectifier unit #1 (top).

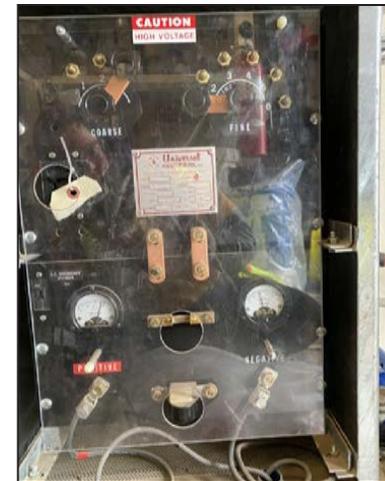
Photo 8: View of rectifier unit #2 (bottom).

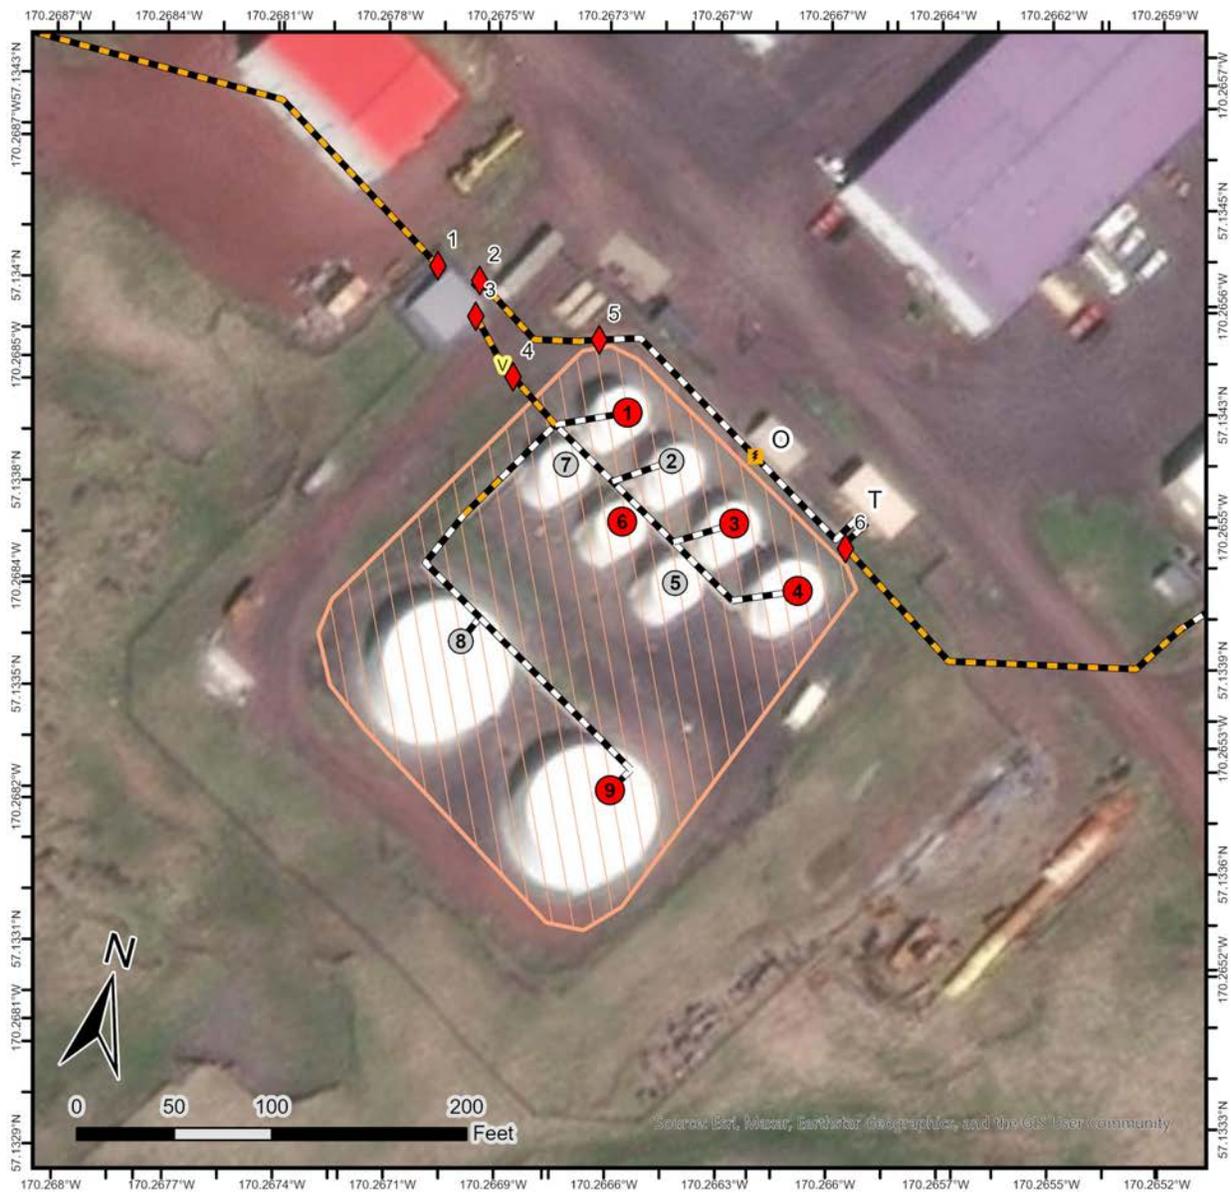
Figure B-1 Tank Farm Test Locations

Tanks 2, 5, 7, and 8 not tested because empty.
