LEE COUNTY PAVEMENT CONDITION REPORT (PASER)

Rockyford Road North of Briar Knoll Road

LEE COUNTY HIGHWAY DEPARTMENT

4/15/2025

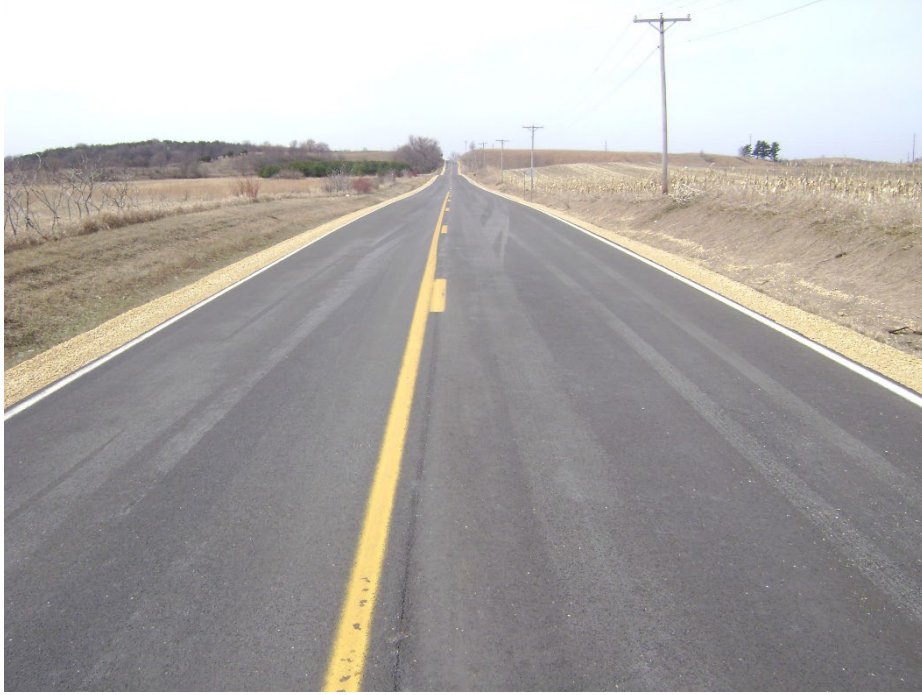
Asphalt Rating 9 – Excellent, recently placed HMA overlay

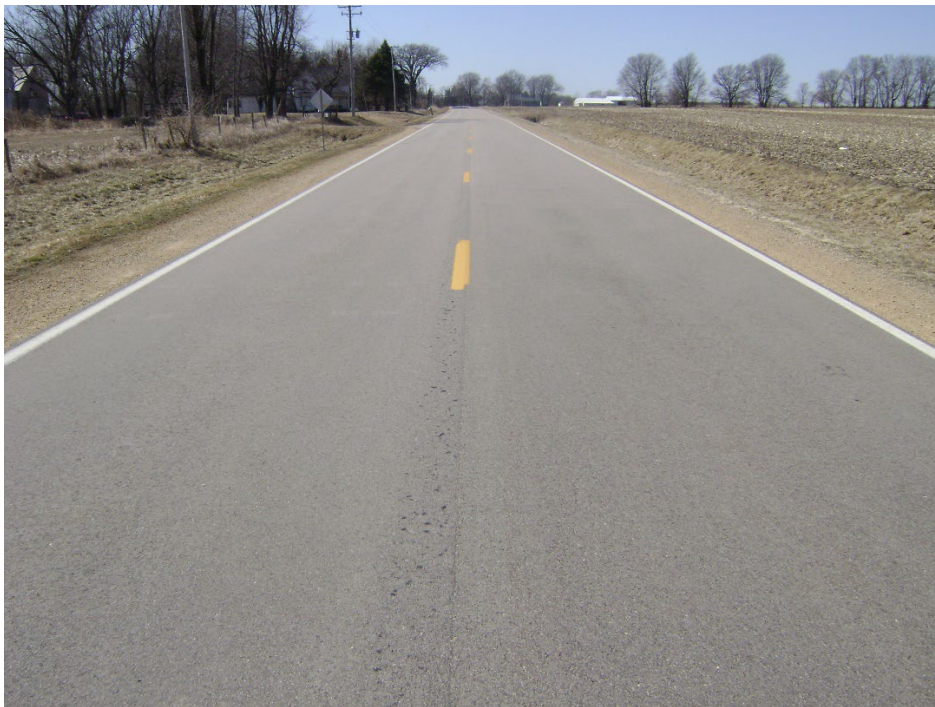
Asphalt Rating 8 – Very good, no issues of concern

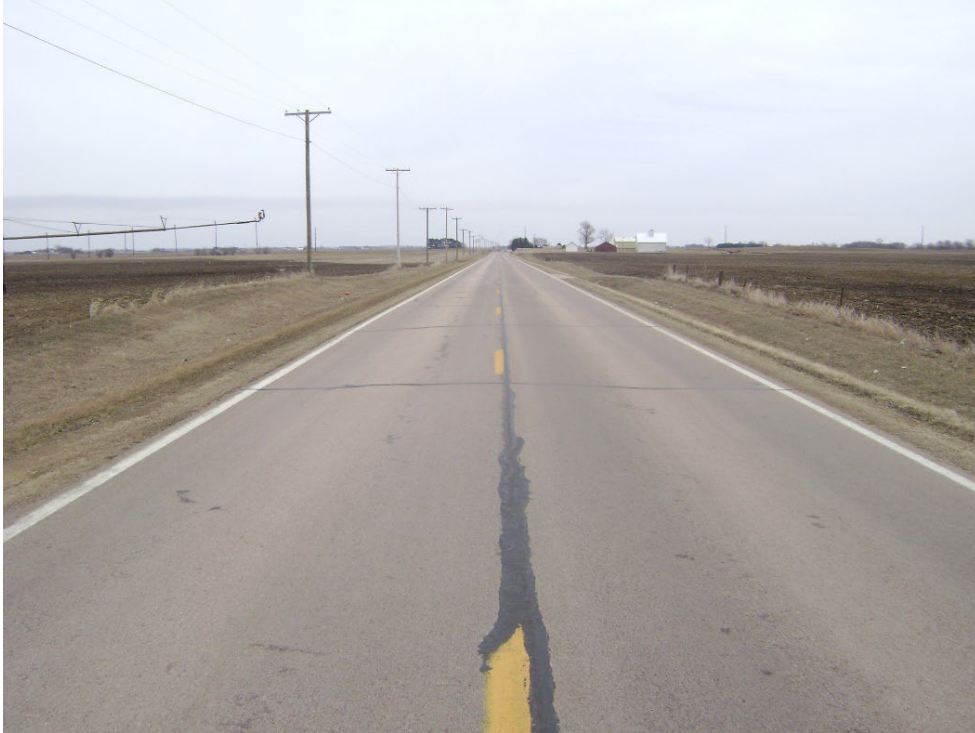
Asphalt Rating 7 – Good, transverse cracks more than 10 feet apart with crack filler

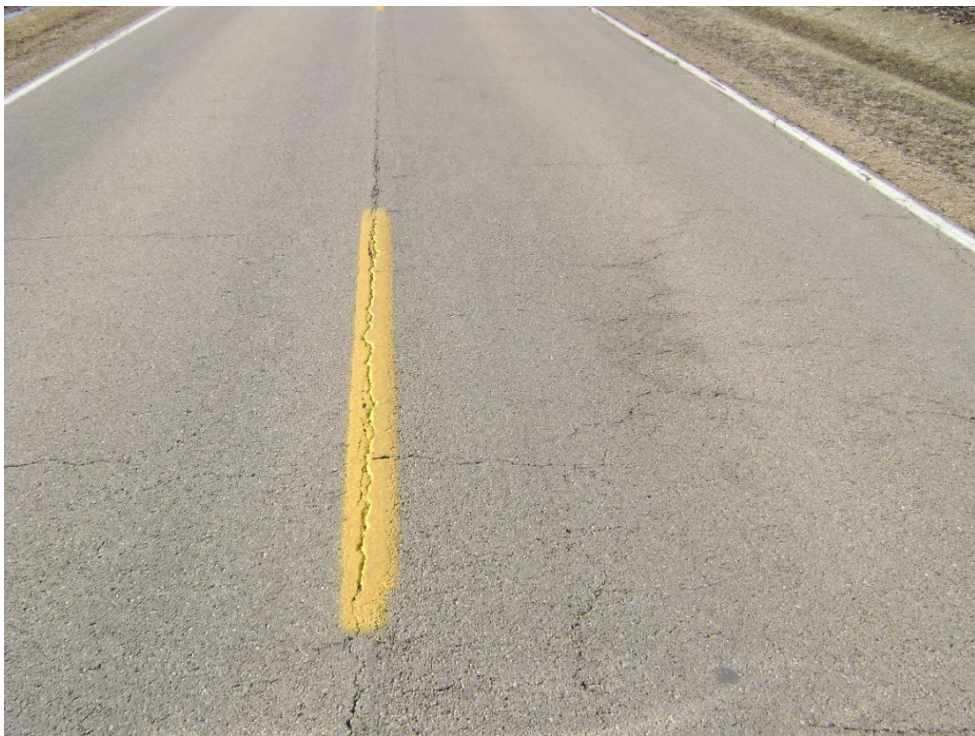
Asphalt Rating 6 – Good, transverse cracks less than 10 feet apart

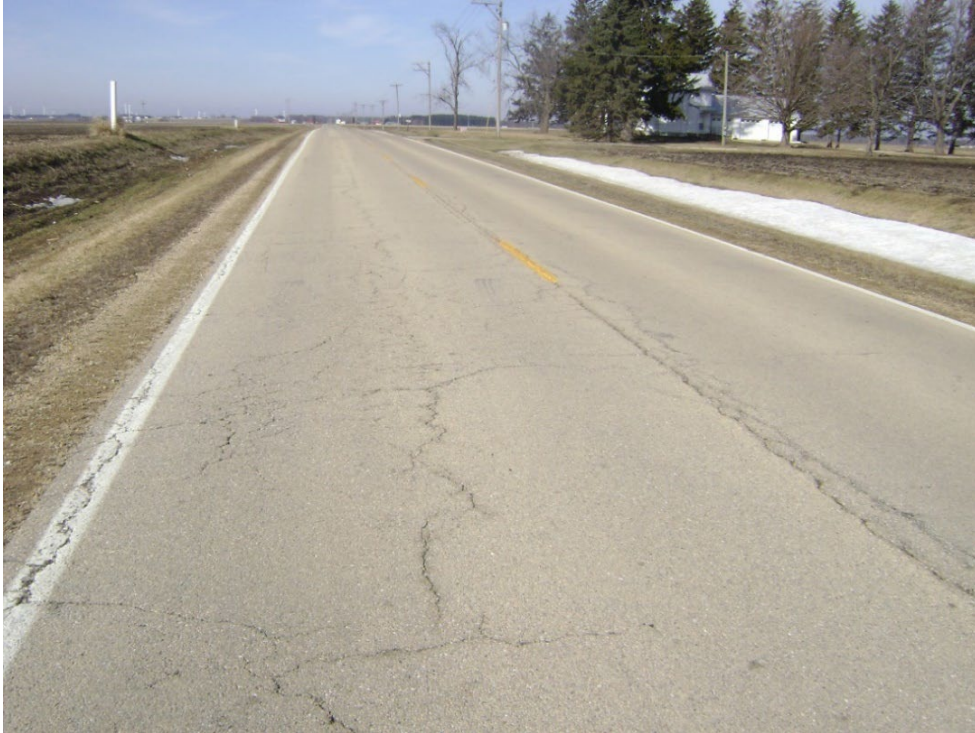
Asphalt Rating 5 – Fair, block cracking up to 50% of area

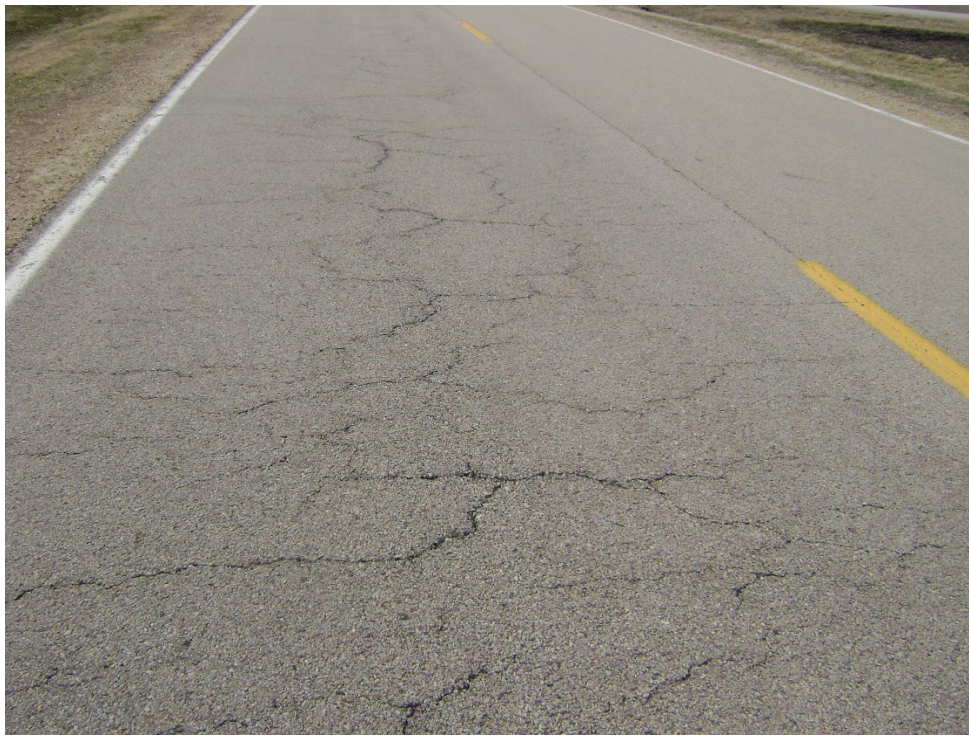
Asphalt Rating 4 – Fair, irregular shaped block cracking over 50% of pavement

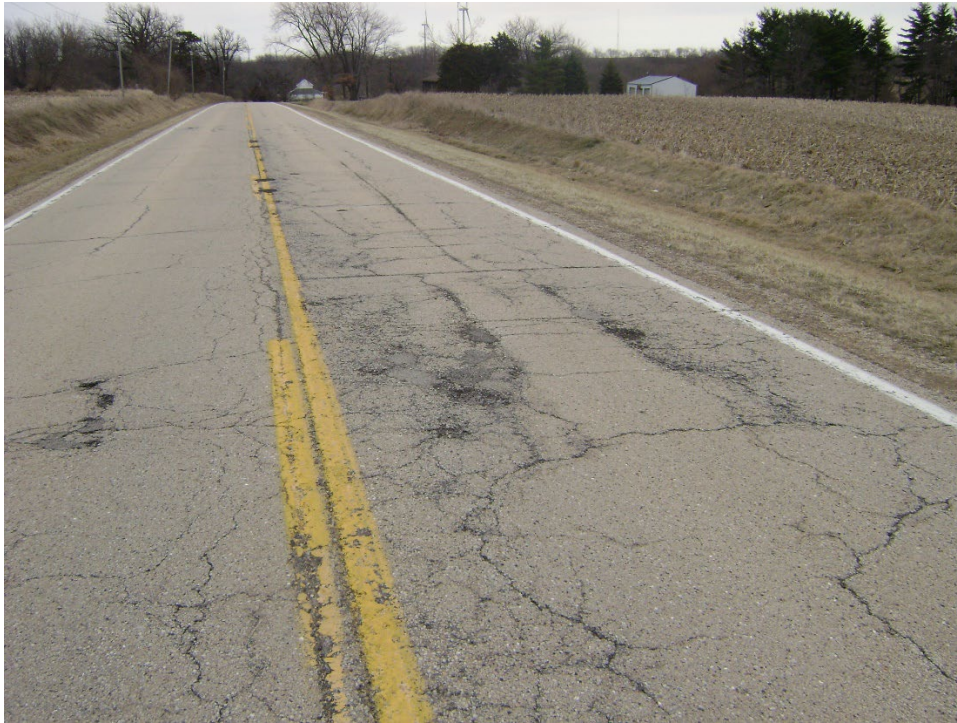
Asphalt Rating 3 – Poor, alligator cracking and potholes beginning

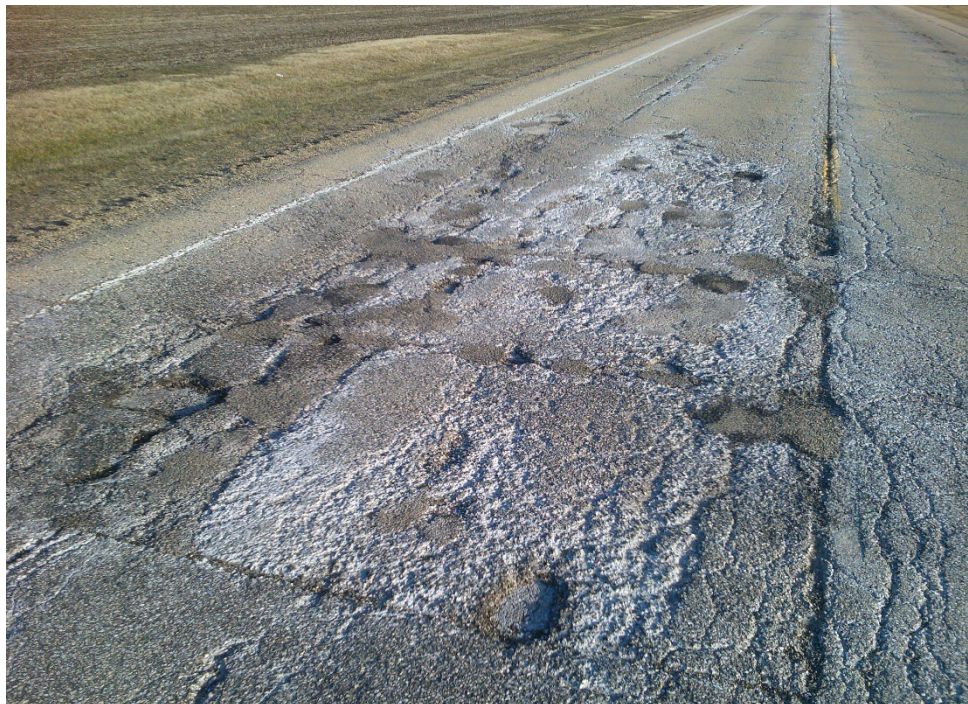
Asphalt Rating 2 – Very Poor, potholes and patching in poor condition

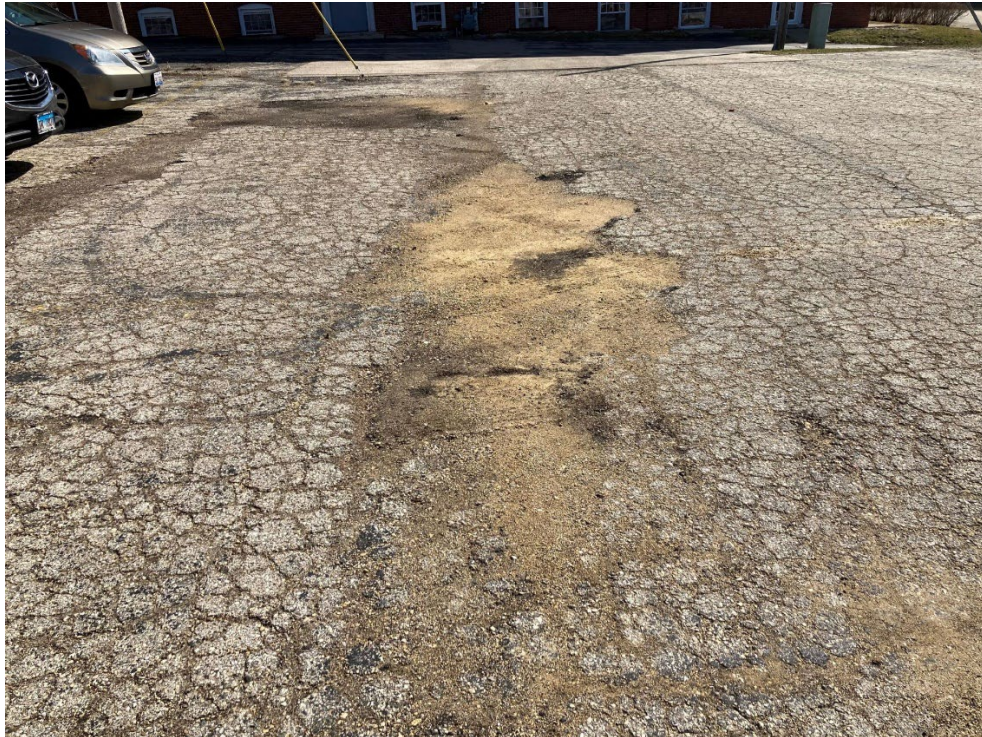
Asphalt Rating 1 – Failed, surface has lost its structural integrity

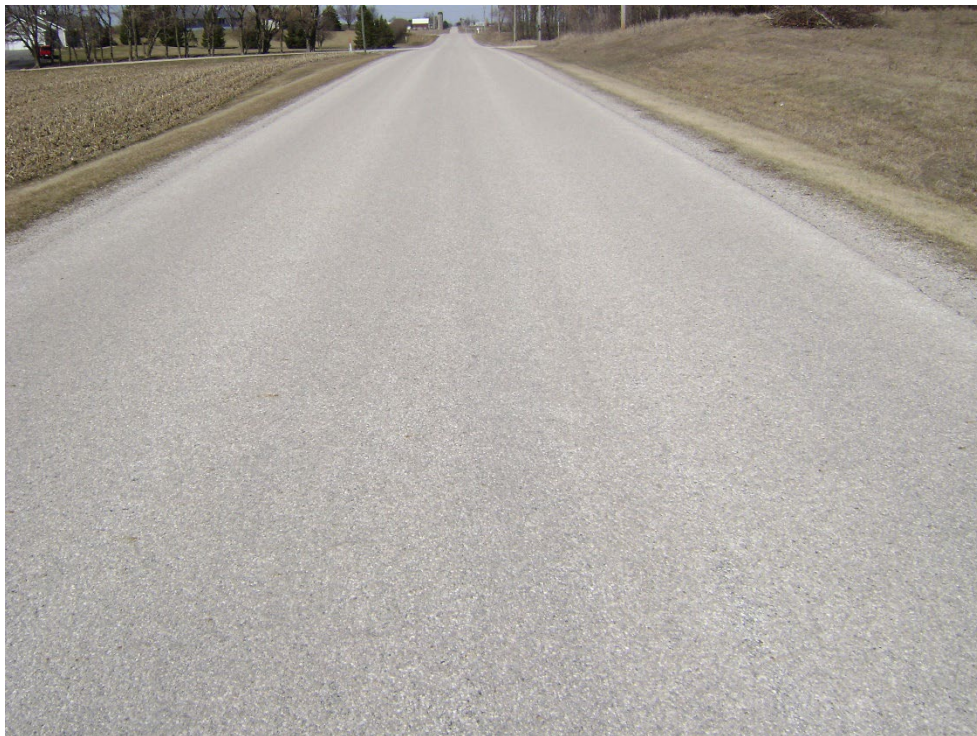
Sealcoat Rating 5 – Excellent – no issues/like new

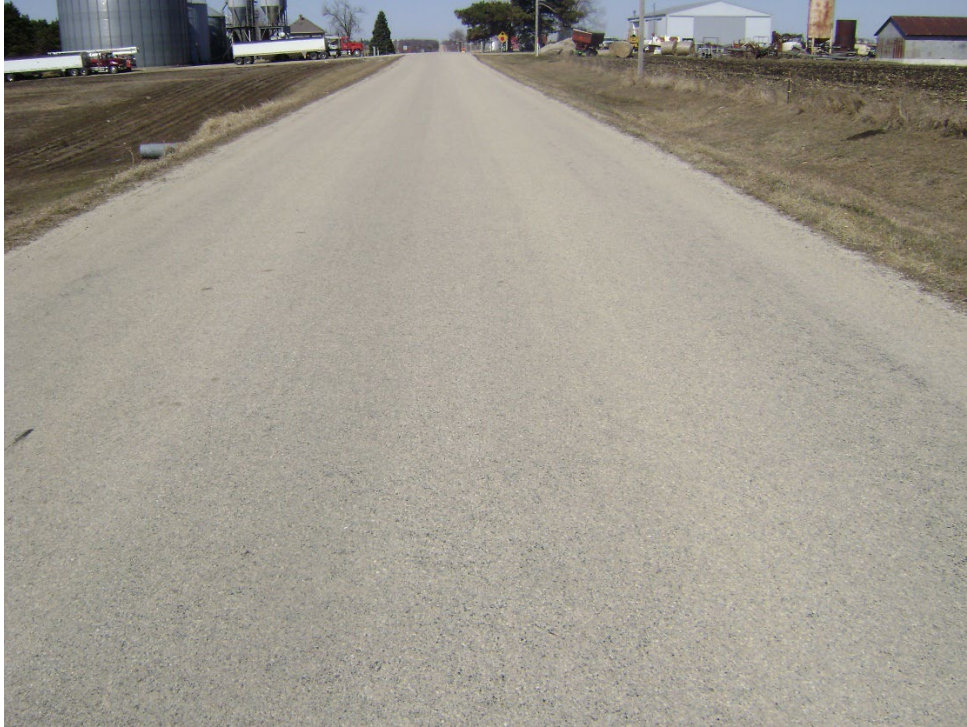
Sealcoat Rating 4 – Good – some aggregate loss

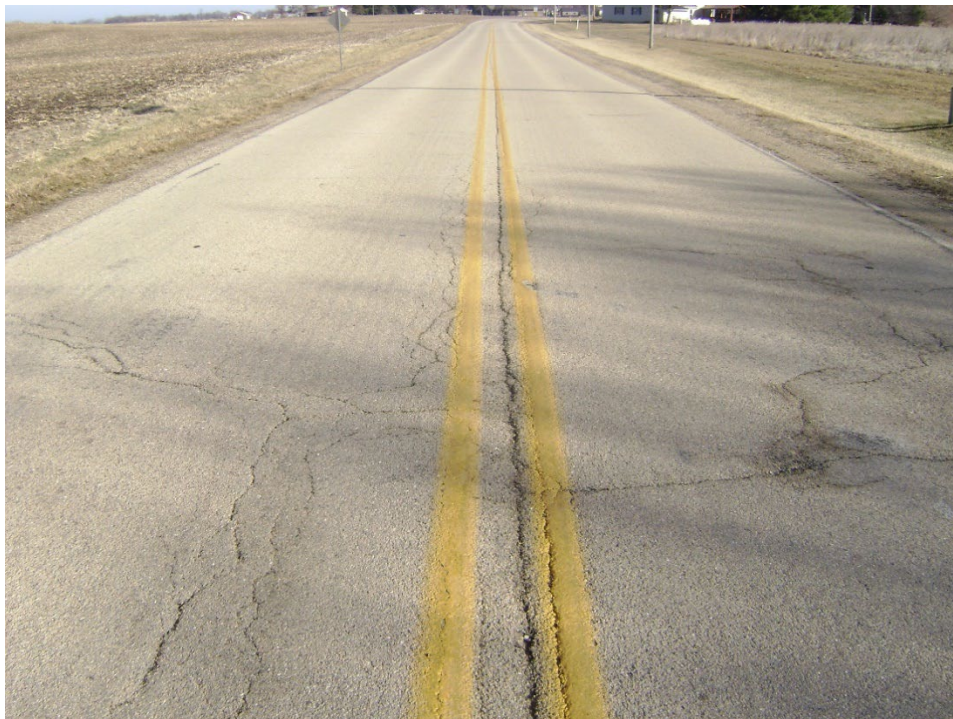
Sealcoat Rating 3 – Fair – cracking throughout sealcoat

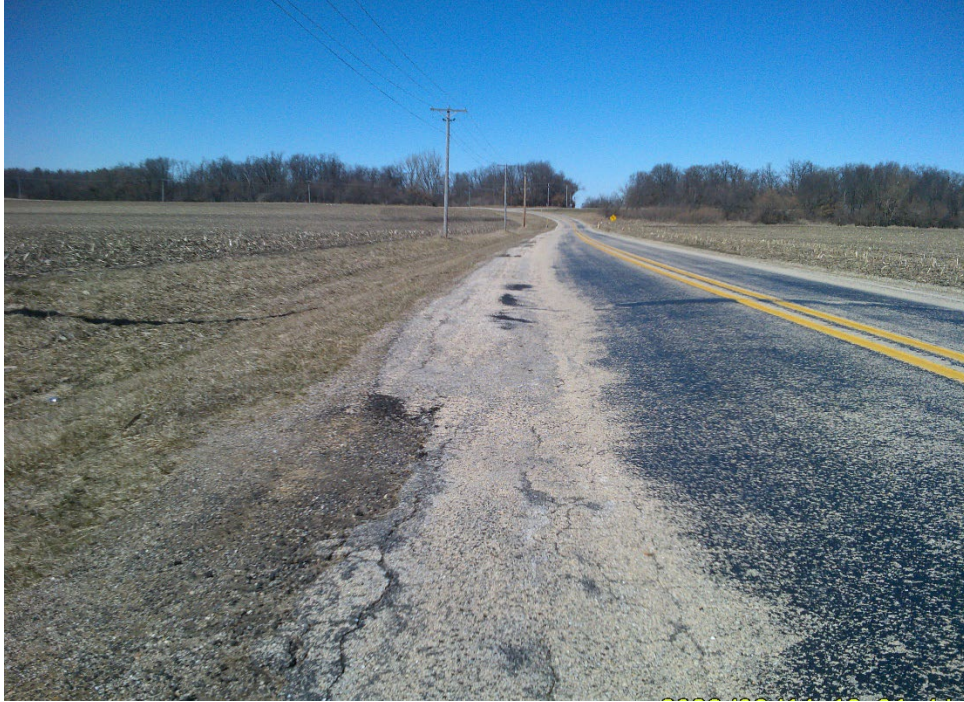
Sealcoat Rating 2 – Poor – Flushing, edge cracking and severe rutting

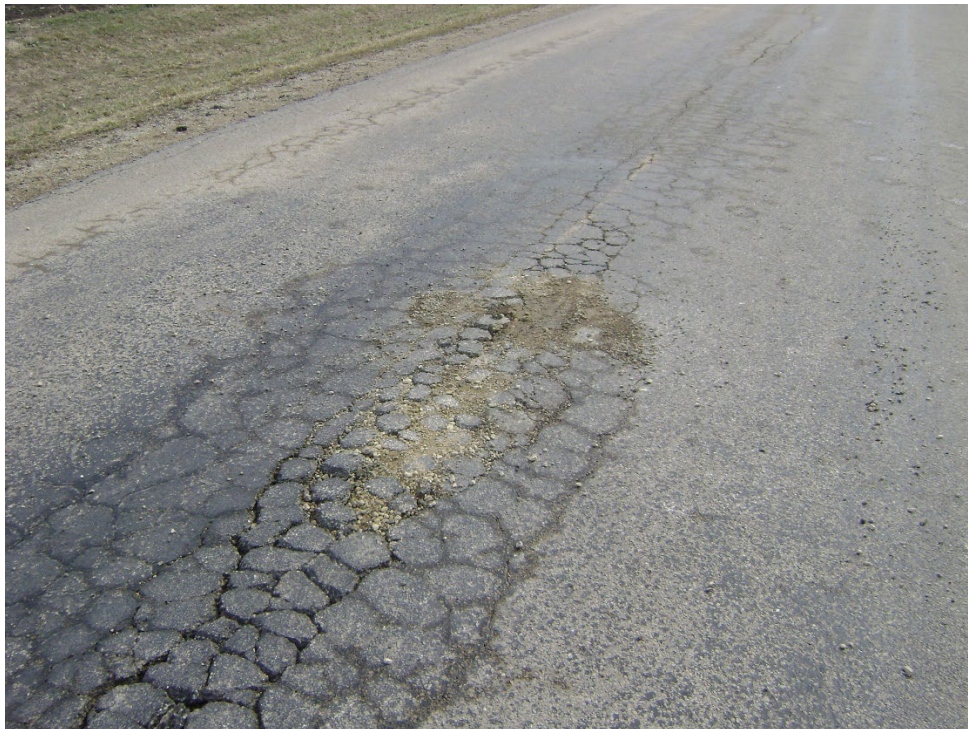
Sealcoat Rating 1 – Failed – loss of surface and mud is pumping into stone layer
