Rochester CUSD 3A Phase 4 Projects

Phase 4 Proposal Highlights

- Matching Maintenance Project at HS & EC-1
- Indoor Air Quality Project at ES2-3

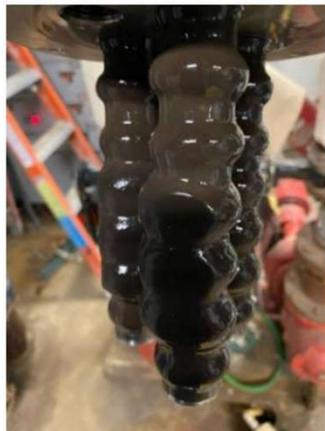
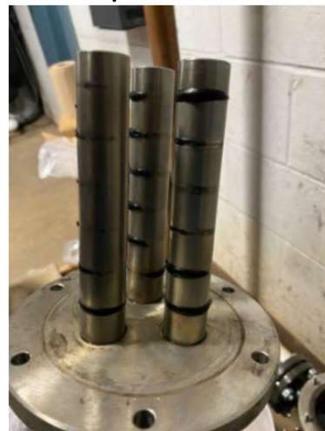
EC-1 Hot Water Loop

During PH2, Veregy partnered with Jaytech Water Solutions to treat the closed loop boiler system at EC-1. The pictures on the right show the amount of metallic debris that the new BoilerMag filtration is catching.

Aliquot PRO - Closed Loop Systems - Hot Water Loop (2022-12-16 15:32)

Aliquot PRO - Closed Loop Systems - Hot Water Loop (2023-12-19 14:38)

Rochester SD is treating the closed loop systems across campus to improve efficiency and extend system lifetime operation.

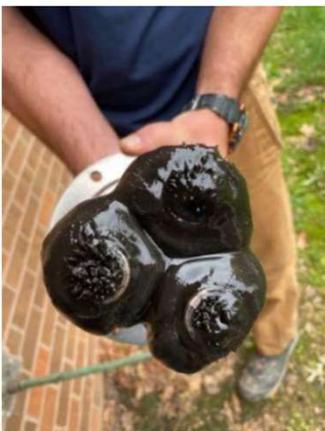
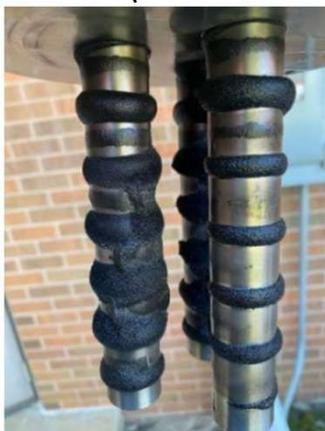
EC-1 Chilled Water Loop

A new BoilerMag was also installed on the chilled water system, resulting in an even more dramatic increase of water clarity. See pictures.

Aliquot PRO - Closed Loop Systems - Chilled Loop (2023-05-16 17:46)

Aliquot PRO - Closed Loop Systems - Chilled Loop (2023-11-01 19:23)

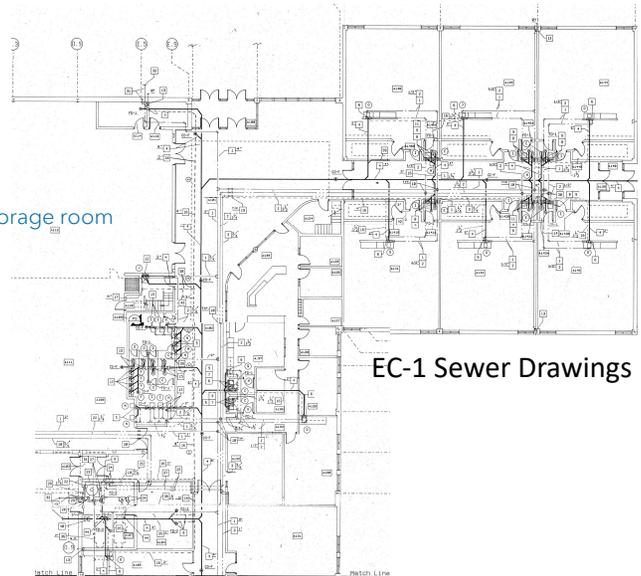
EC-1 Sewer Drawings

- ✓ EC-1
 - Extensive Sewer Line Repair (3", 4" & 6")
 - Main Lobby Sewer Line Replacement
 - New Cleanouts
 - Final Jetting and Cleaning
 - Floor Tile Work

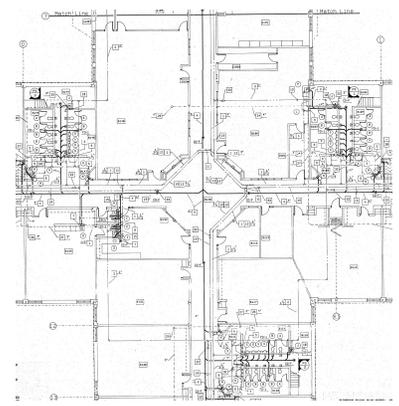
High School J-Wing Water Service

- ✓ HS
 - J-Wing Water Isolation Valve
 - Assumes line enters building under storage room
 - Floor Tile Work

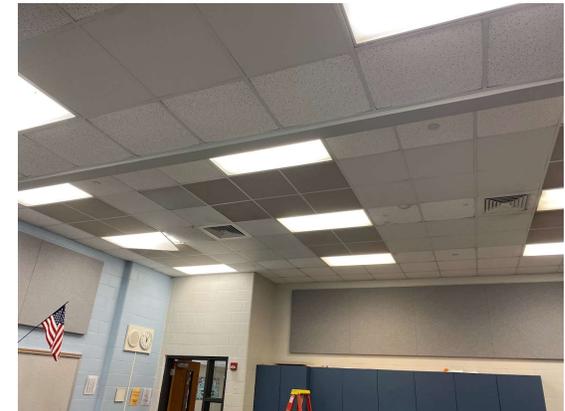
- ✓ Existing Conditions
 - Humidity problems throughout building, appears to be caused from air infiltration from outside that condenses on cool, exposed ductwork above ceiling
 - This can cause musty odor in classrooms
 - Likely air leak above ceiling from ductwork
 - Roof/Wall joint needs sealing to reduce air infiltration
- ✓ Recommendations
 - Roof-Wall joint sealing entire perimeter to air seal building
 - Supply duct external insulation for AHU-7 & AHU-8.
 - Remove and re-install existing ceiling tile and grid as necessary.
 - Duct repair of air leaks at AHU-7
- ✓ General
 - Project management
 - Permitting & As-Built drawings
 - Insurance, Warranty & Bonds
 - Project risk
- ✓ Price
 - \$102,649

Examples of Wet Ceiling Tiles below AHU7/AHU8
