Final Report for

## KCTCS - LAUREL SOUTH CAMPUS FEASIBILITY STUDY SOMERSET COMMUNITY COLLEGE

KCTCS Somerset - 235 S Laurel Rd  
London, Kentucky 40744

1 September 2023

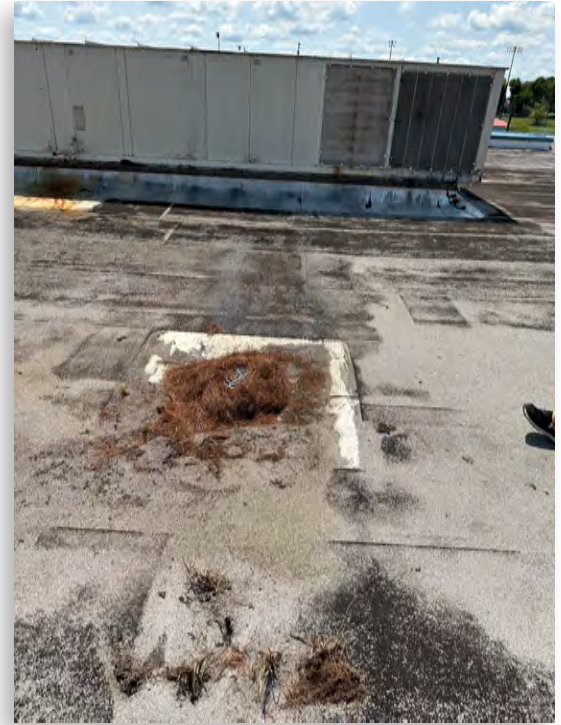
The problem with the blocked roof drains was consistent on the roof of the 1975 addition. All four of the roof drains were covered in pine needles and surrounded by piles of granules. The discoloration of the roof where the granules have become dislodged, exposing the modified bitumen membrane to UV light is also apparent here. Note the mechanical curb under the unit in the background: with the addition of new roof insulation there will be little room to properly flash the curbs into the roof system. All roof penetrations will need to be extended to the new roof level.

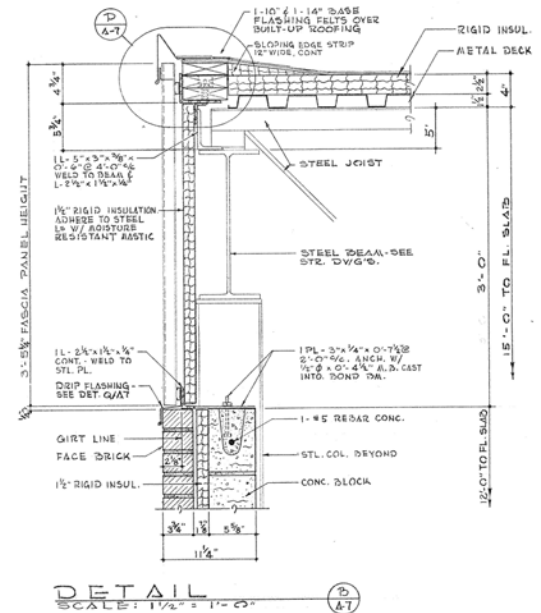
The detail at right is a typical roof detail from the construction documents for the 1975 addition. The detail shows the roof edge flashing and the 2½” of roof insulation called for in this system. Current IECC standards call for as much as 5” of continuous rigid insulation. It is also worth noting that the flashing is not designed to redirect water that has entered the wall system to the exterior. Any water that enters the wall from above will easily find its way into the wall cavity. (The construction documents have no details showing the installation of the relief angles.)

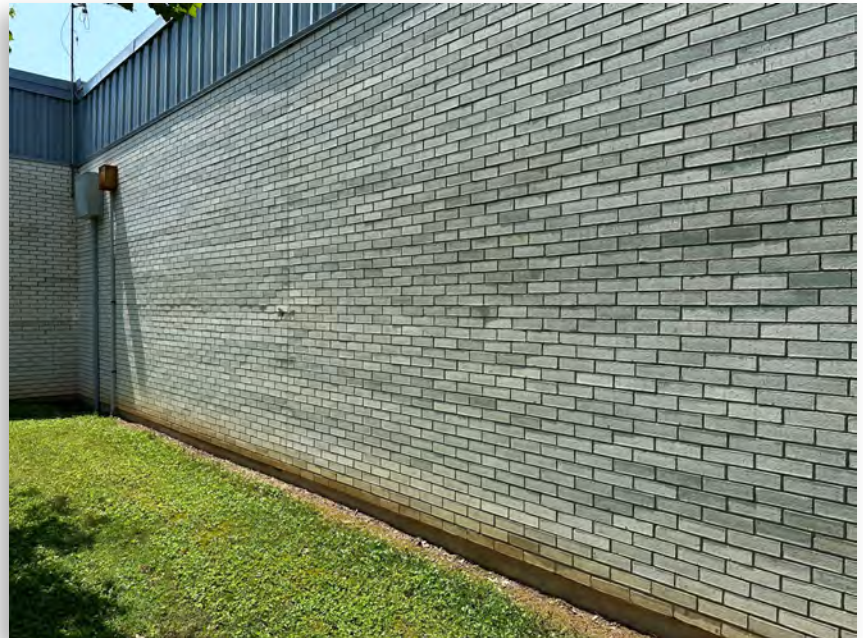
These deformations in the brick are subtle in most places and difficult to document. However, in this photo the undulations in the brick surface are fairly clear. The familiar horizontal striping associated with the relief angles is also evident.

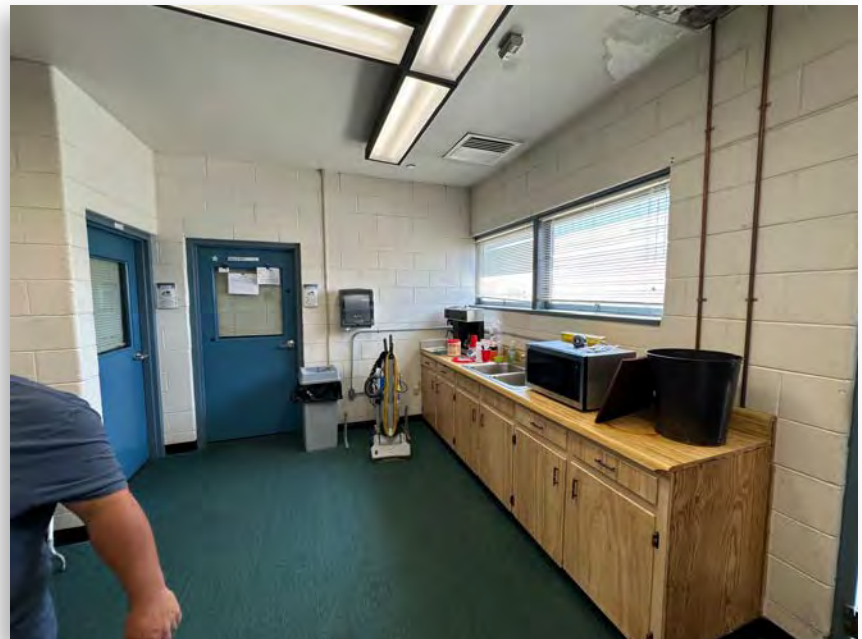
These doors, in what is now the teacher's lounge, originally served spaces associated with the original cafeteria. These doors to offices should reflect the space they serve. This is another space that has been adapted to its current use. The carpet, casework and lighting are not appropriate for a teacher's lounge and should be updated.

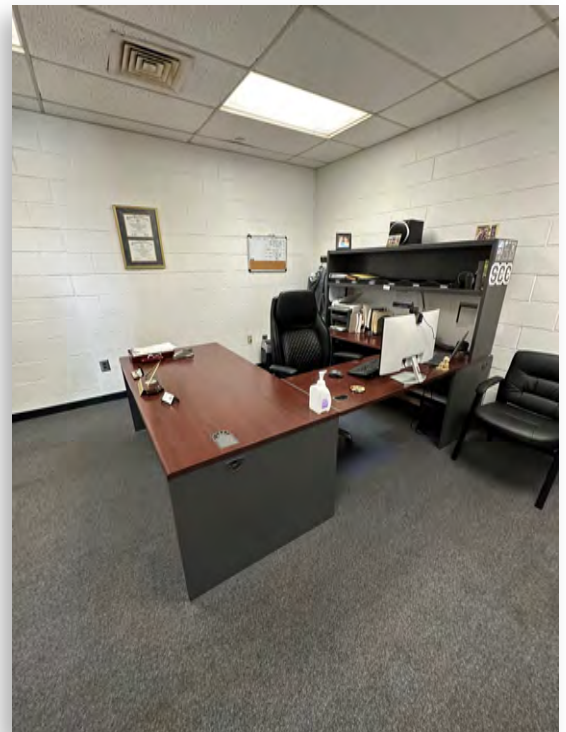
This is the office of the Dean of Business and Applied Technology. It has been converted from the reception area (1971) serving the offices behind it to a Book Room (1975) and back into an office. It still has the transaction counter and window serving the lobby in place.

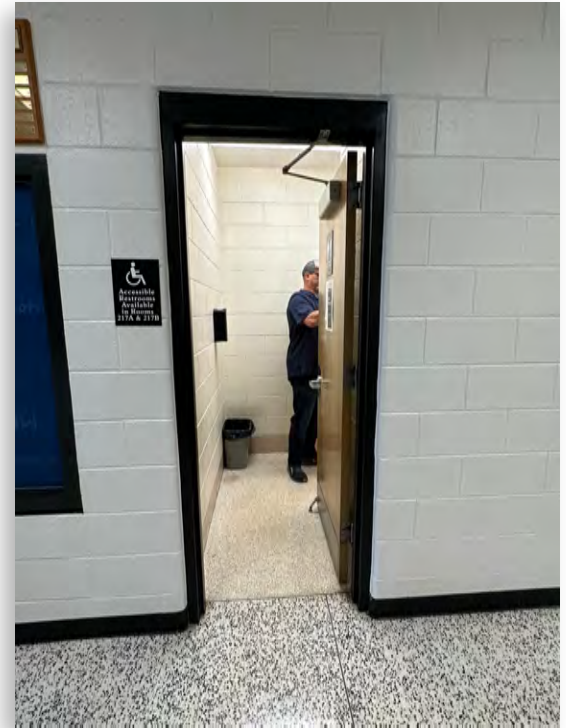
The sign to the left of the door explains that “accessible restrooms are available in Rooms 217A and 217B” at the other end of the building. The door here is 32” wide and leads into a series of switch backs to enter this unisex restroom. The other restroom that was originally paired with it has been converted into a lactation room to the right down the corridor. This building, designed and constructed long before the Americans with Disabilities Act was passed into law has very few accessible features. The fact that it was built with CMU walls and terrazzo floors makes changes to the restrooms very difficult. Moreover, by the current Kentucky Plumbing Code, the building should have 13 water closets for females in the design. The existing count falls far below this number. (1:25 water closets to females and 1:50 water closets to males).

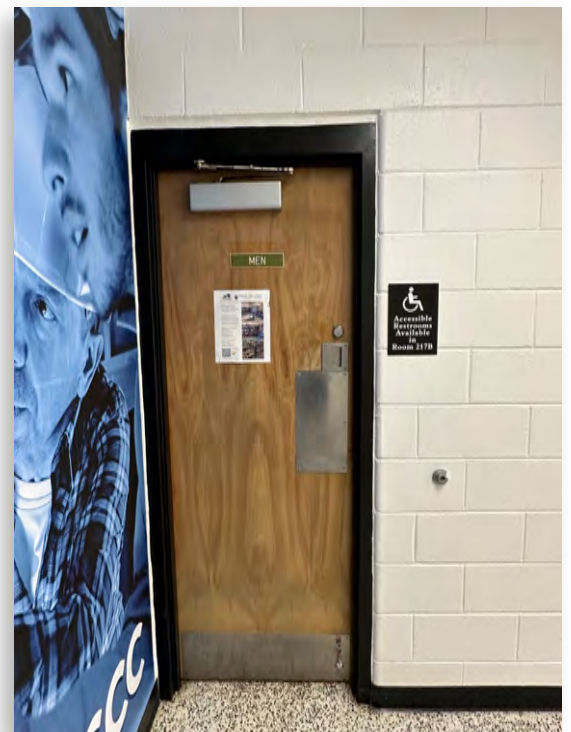
This restroom is probably the most problematic in the building. In addition to opening into a tiny vestibule with another door, the restroom itself is only 6’-0” wide (see next image) and contains three water closets and three urinals (one of the largest in the building). The fact that it is served by two doors that are only 28” wide makes it uncomfortable for most people. The women’s restroom just to the right of this image has the same entry configuration but only serves a single person.

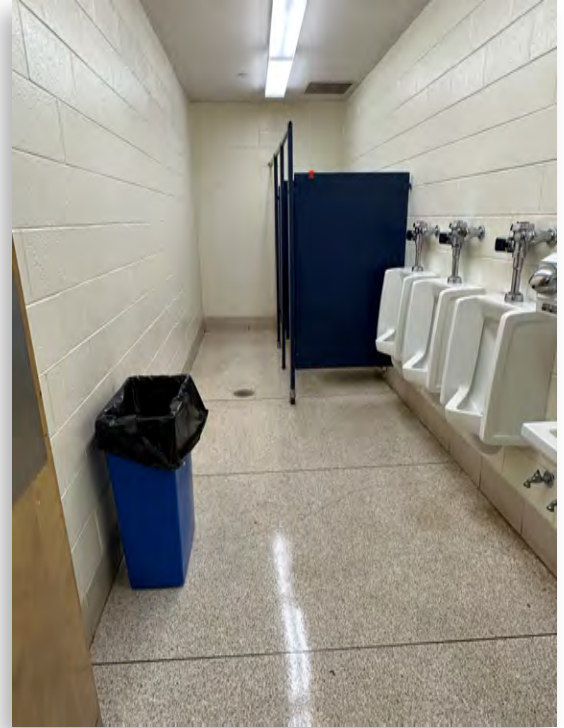
This restroom, behind the door in the previous image, is one of the largest restrooms in the building (fixture-wise). It contains half the required fixtures for males. At just 6'-0" wide it is almost impossible to make ADA accessible.

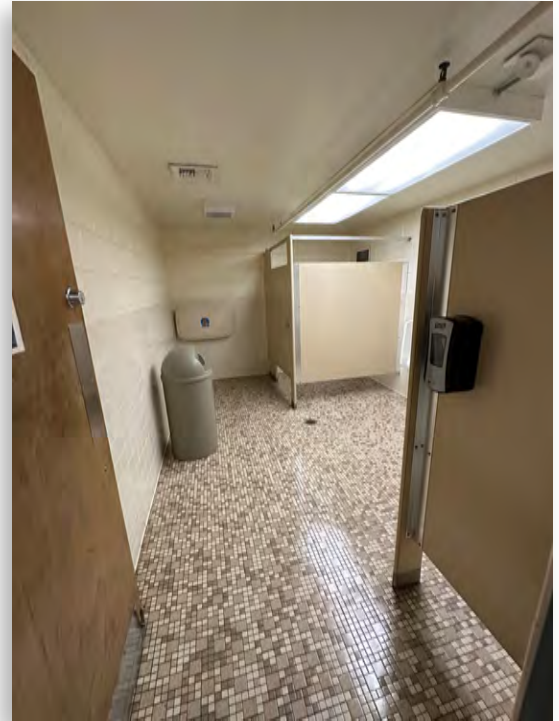
The accessible restrooms at 217A and 217B are actually in 217B and 217C according to the room plan provided to WPA. However, since there is no room signage outside the restrooms, it hardly matters. This photo of the men's room shows that it meets the bare minimum required for accessibility: One toilet, two urinals and two sinks. The lighting and finishes are well cared for but minimal.

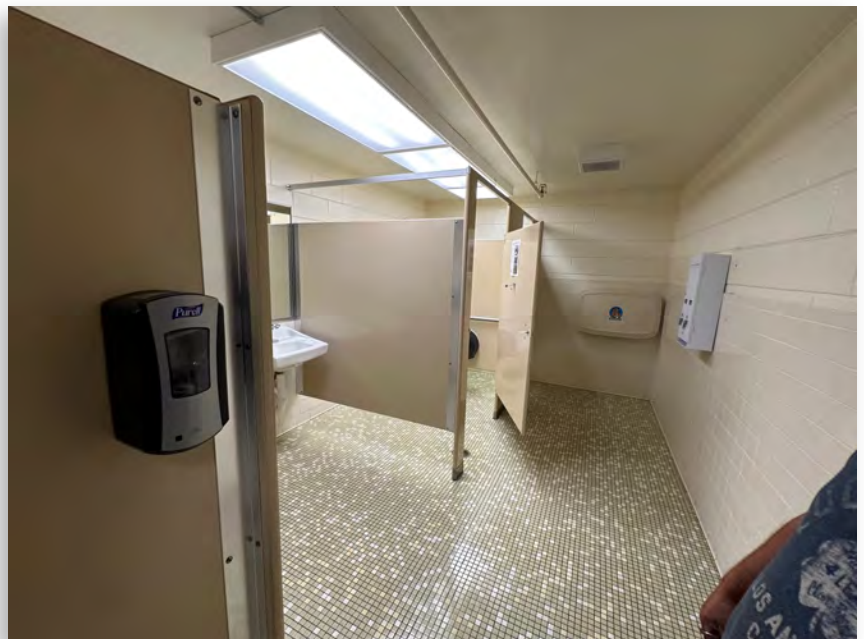
The women's room next door is similar in size and in its lack of lighting and minimal approach to finishes.

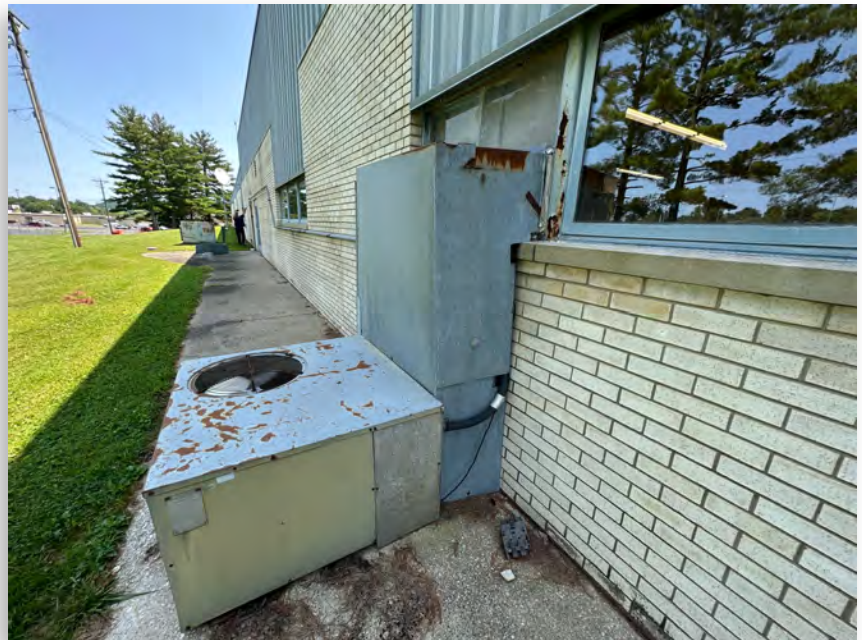
The photo at right is a good starting place for a discussion about the mechanical systems in the Laurel South building. This mechanical unit is serving the former masonry shop which has been converted into the electrical shop. The HVAC needs changed and this is how those needs were met.

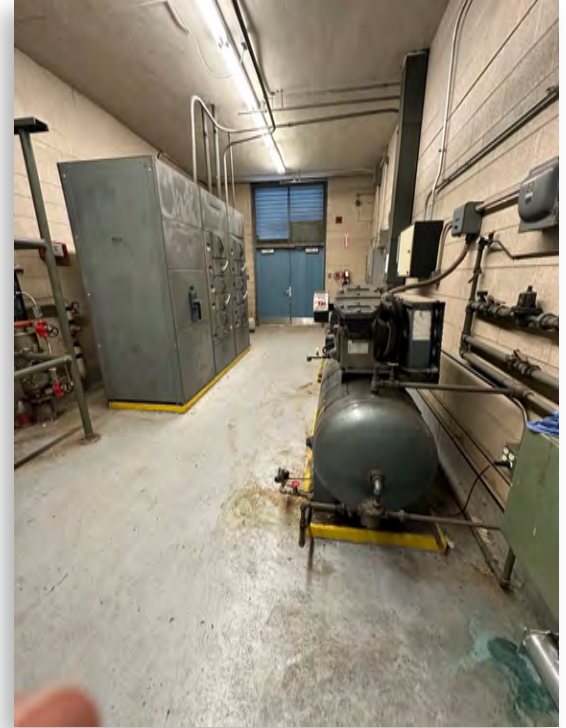
This image shows the mechanical room in the original 1971 building. The main switch gear and various air compressors are visible. Most electrical and mechanical equipment is original to the building.

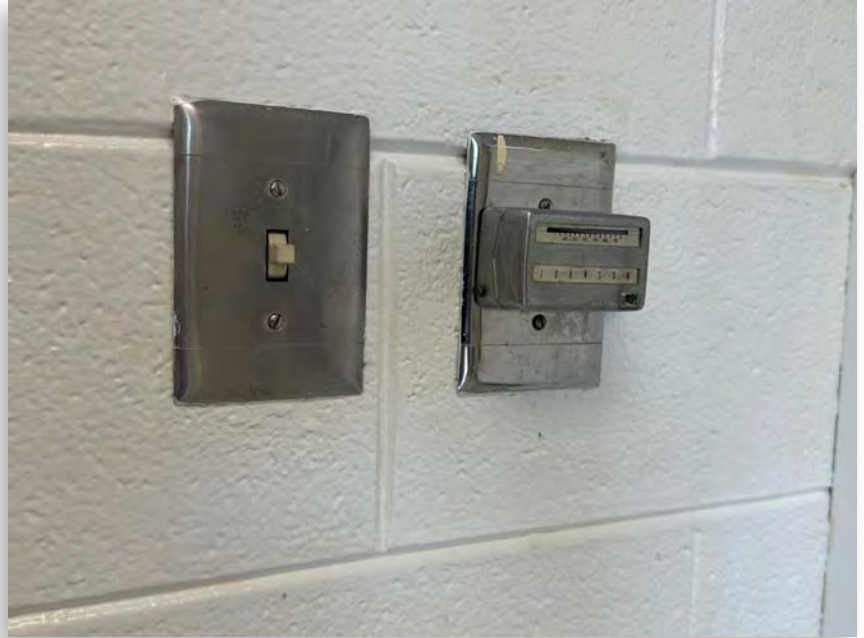
Lighting and HVAC controls are outdated and should be upgraded with the new mechanical units.

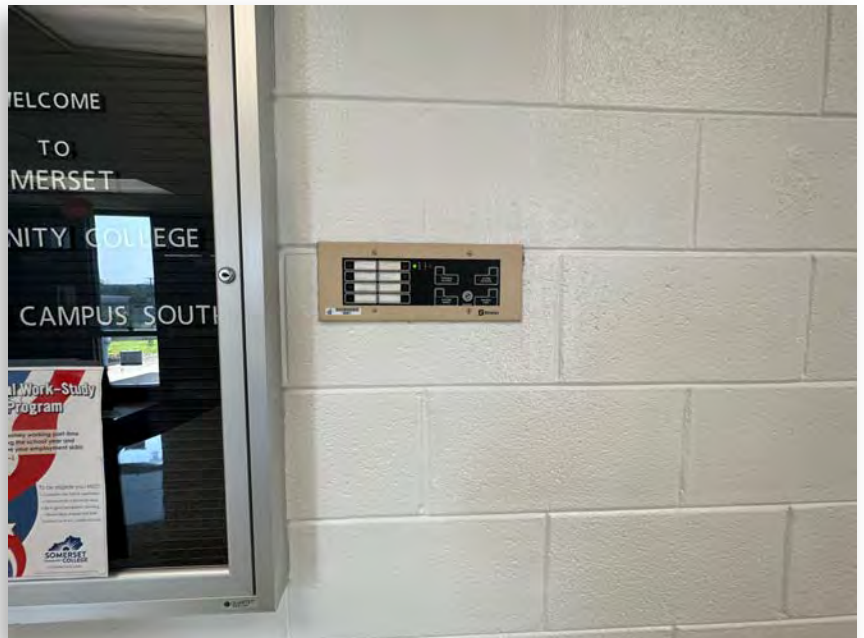
There are a variety of panels and devices associated with the fire alarm. Many of these are outdated and should be upgraded if no longer serviceable.

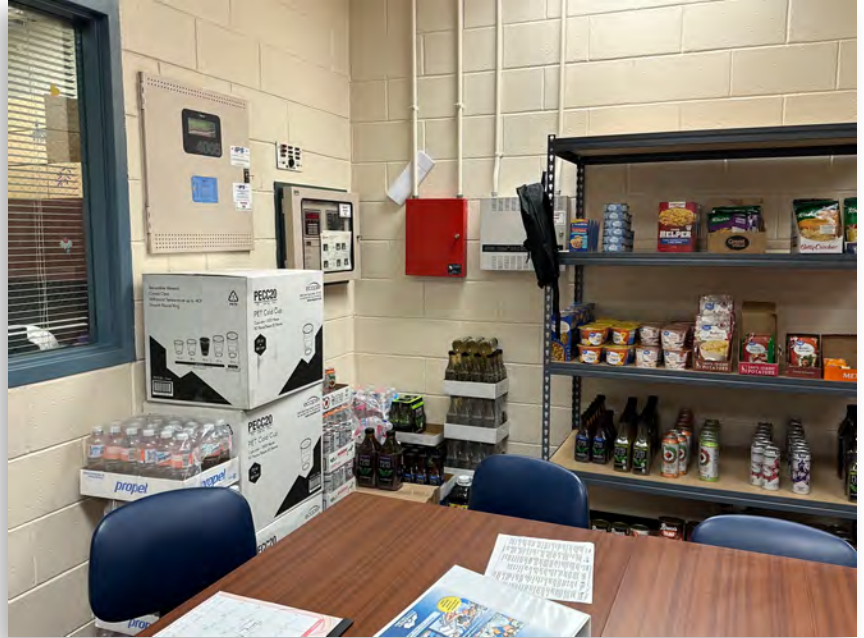
This photo shows the fire alarm and master clock panels against the back wall of the food pantry. The Simplex 2350 master clock system is no longer made. However some version of the Simplex 4005 Life Alarm and the 4009 IDNet NAC Extender appear to be available as recently as recently at 2021. WPa has been told that there have been no upgrades to the systems since the building was renovated in 1975.

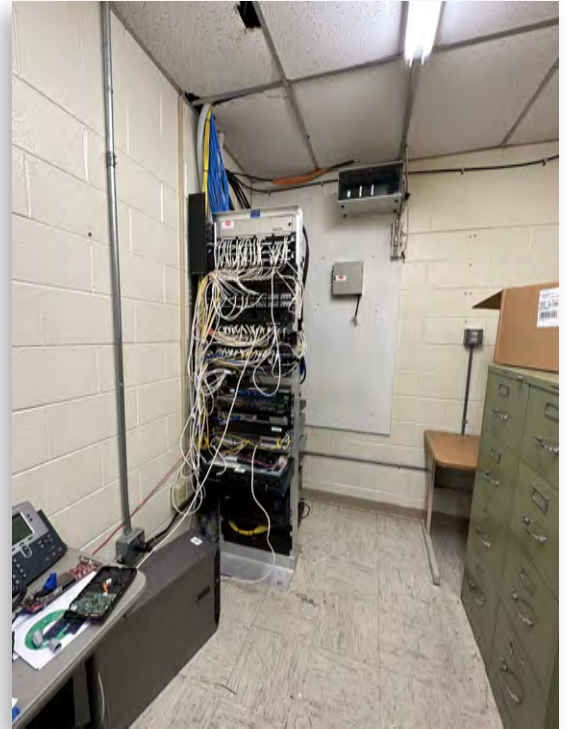
This view is of the communications room. This space was originally a first aid office. The building needs a communications / data room built for this purpose.

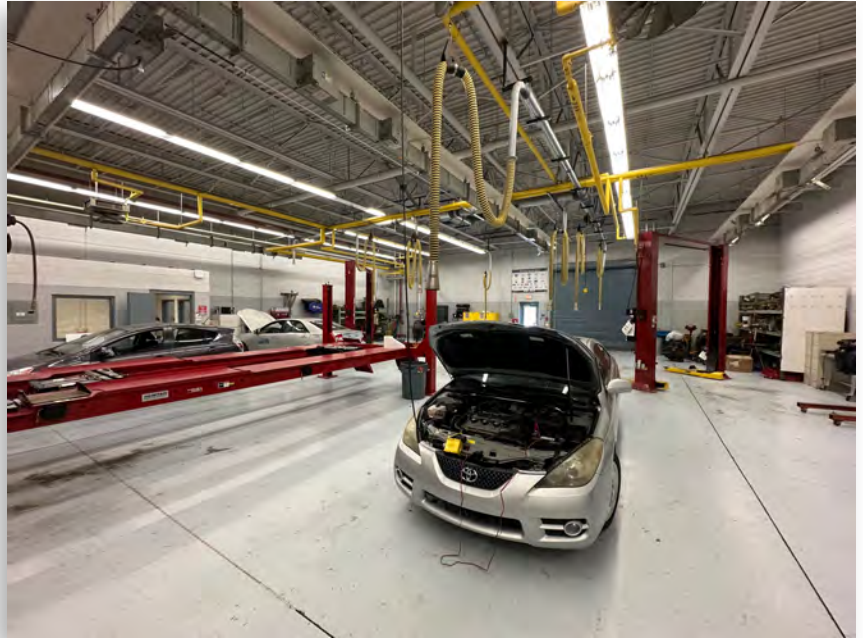
The Automotive Lab has a number of nozzles attached to an exhaust extraction system. These systems are crucial when working on a running vehicle indoors. WPA was unable to find about the attachment protocols for the nozzles in place. The ones seen here did not appear to have clips to hold them in place on horizontal exhaust systems like those on the car shown.

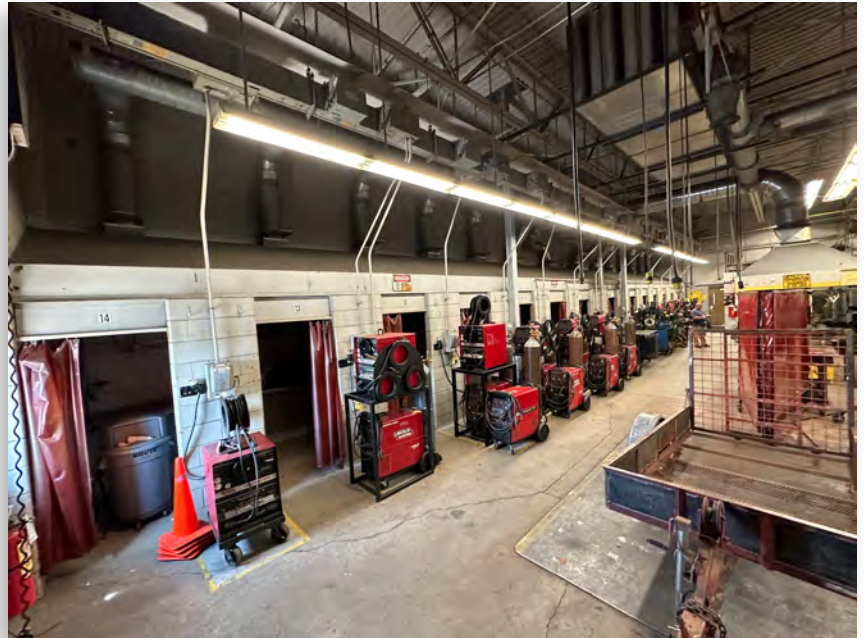
The Welding Technology Lab has an extensive exhaust system with a number of hoods throughout the space. However, the system itself appeared to be aging.

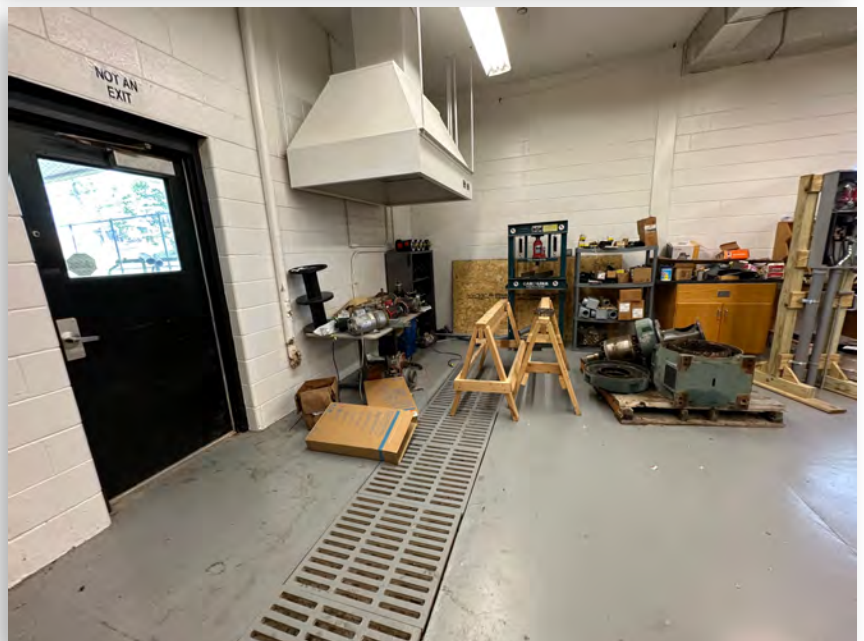
The Electrical Shop has an exhaust system in place. However, it is a remnant of the masonry shop which occupied the space in the original design of the building and it is no longer used.

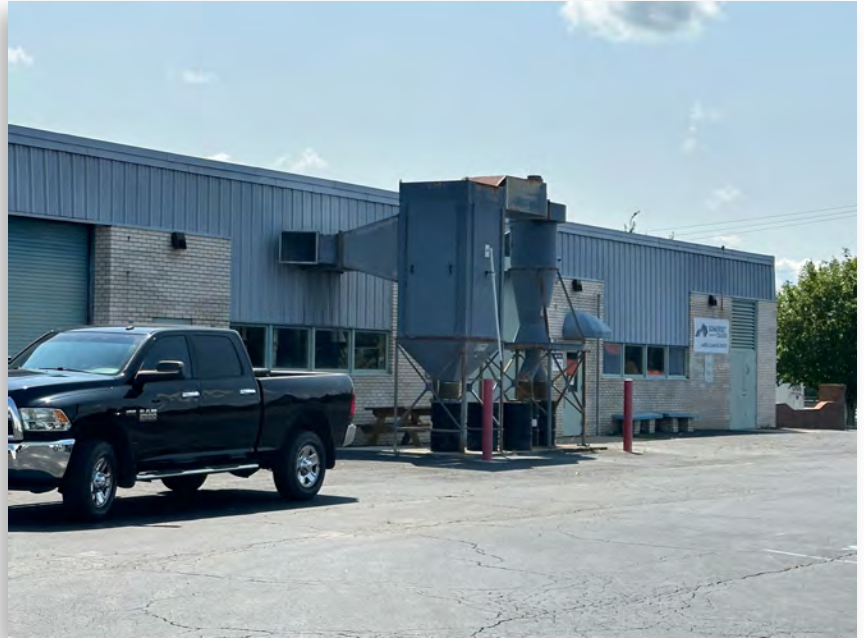
The Construction Technology Lab utilizes a sawdust collection and extraction system to collect sawdust from floor inlets and at various machines. These units exhaust the sawdust and deposit it in the barrels seen below the units. This system is aging and needs to be upgraded.

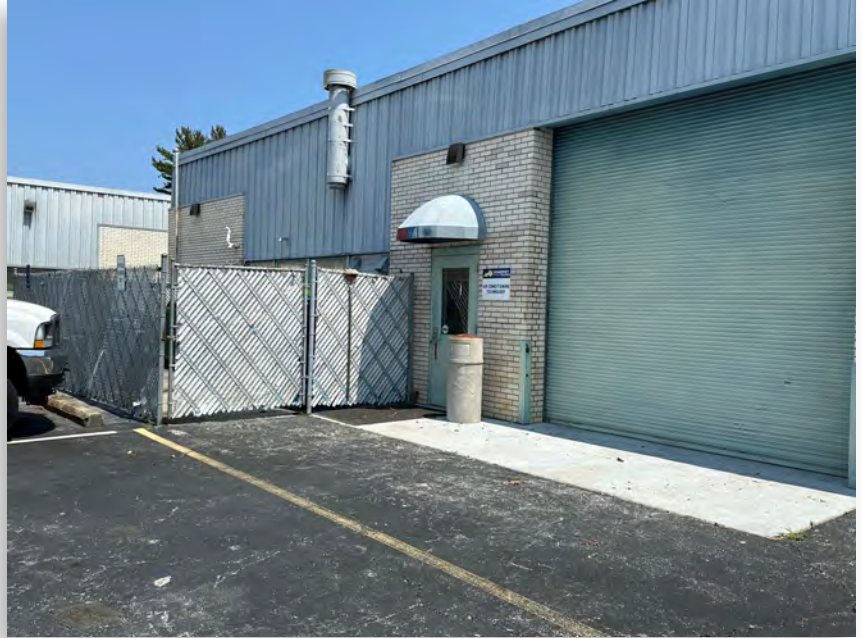
This fenced area is outside the HVAC shop and houses a collection of condensing units associated with the shop. Renovation of the building should address areas like this outside as well.
